Frans Alferink (Wavin Marketing & Technology B.V)

Synopsis

Annex 2 : Impressions of Digging up the old pipes.

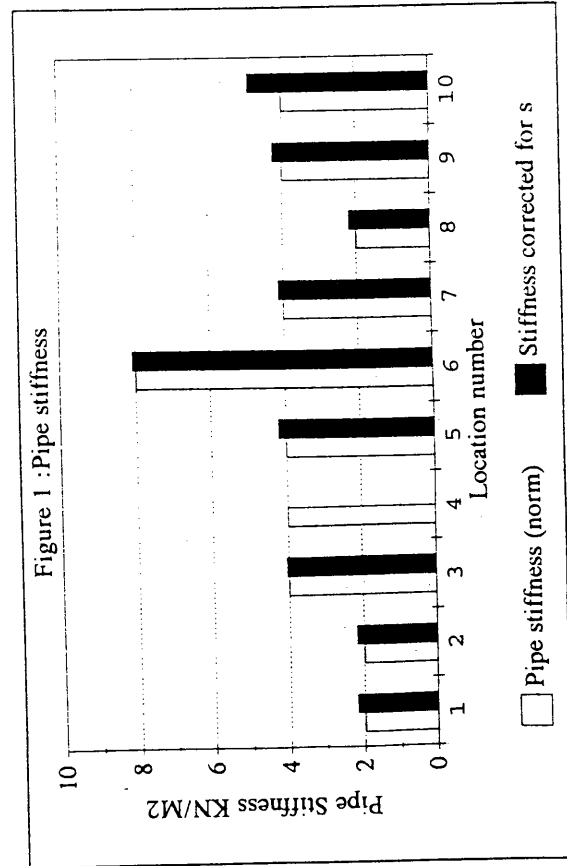
In Figure 1 of Annex 1 the results are summarized. Also the minimum required stiffness according to the pipe class is shown.

Figure 1 of Annex 1 clearly shows that the pipe stiffness does not show any significant change and still fulfils the minimum requirement.

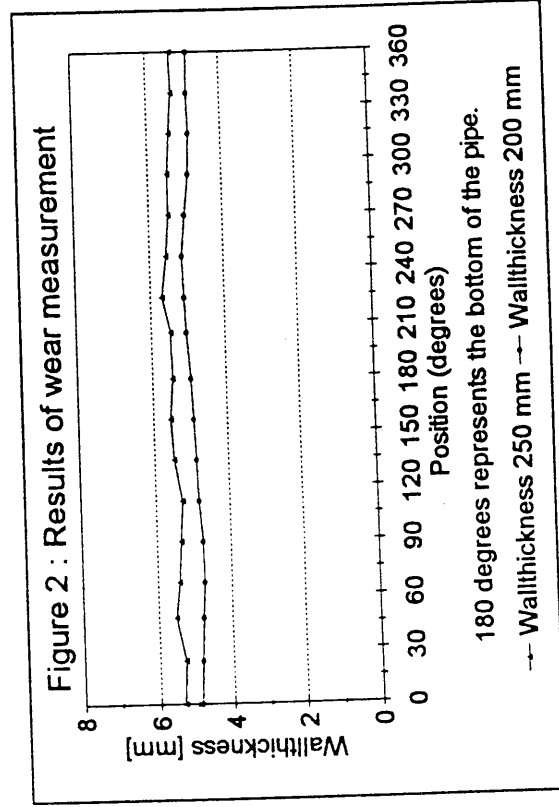
In a few cases (Nøtterøy and Thorshalle) the abrasion has been determined by measuring the wall thickness along the pipe circumference. Figure 2 of Annex 1 shows the results of the measurements.

When abrasion would have taken place, the bottom part should show a thinner wall. The graph shows that this is not the case. So, abrasion is not a big issue for plastics pipes. Remember from the site description, that in the Nøtterøy pipe a lot of stones have been found during cleaning.

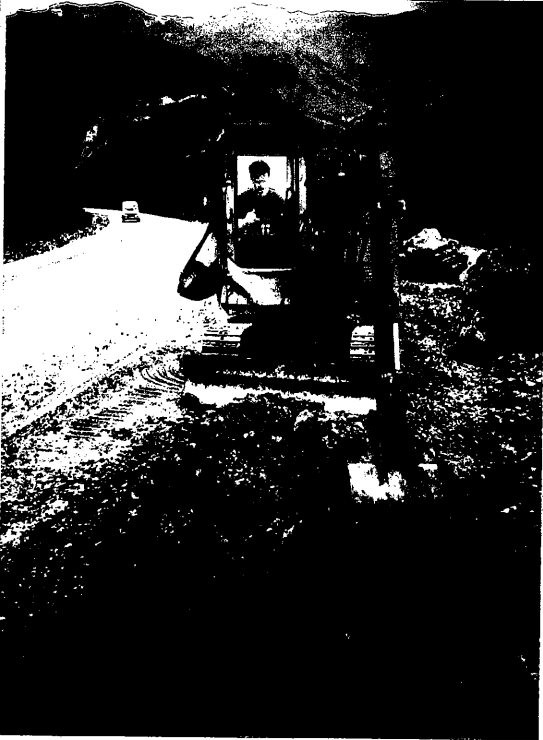
Digging in the French Alps, Courchevel. ▲

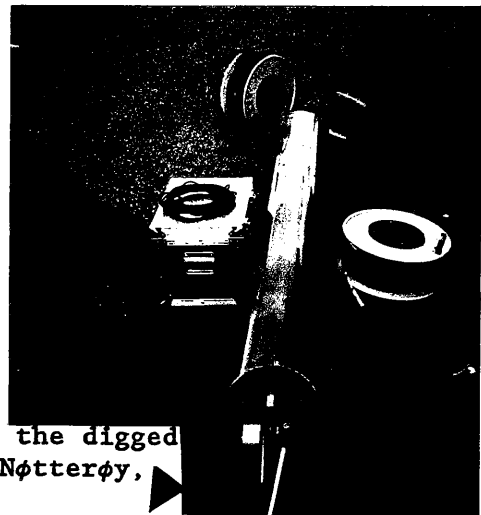
Remeasuring the digged up pipe in Nøtterøy, Norway. ▶
