PREDICTING THE RESIDUAL LIFE OF PVC SEWER PIPES.

A. J. Whittle Iplex Pipelines Australia Pty Limited.

J. Tennakoon Ipswich Water, Queensland, Australia.

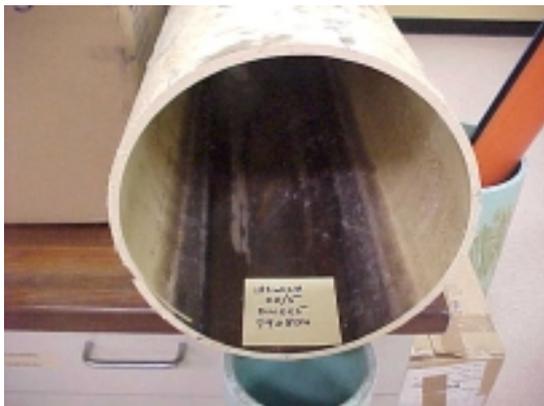
The wall thickness of each pipe was measured by micrometer at 45° intervals around the circumference, starting at the crown. The crown was identified by the markings made at the time of exhumation and was confirmed by the location of the black, sulphide staining at the invert of the pipe (Fig. 1).

Figure 1. Sulphide staining at invert.

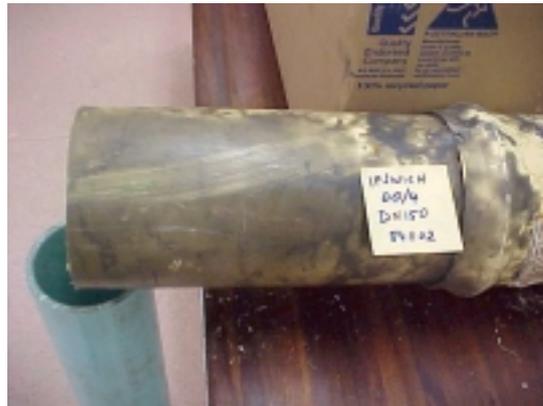
With the exception of sample 00/4, all the joints passed both the infiltration and exfiltration tests. Sample 00/4 leaked in both tests because of damage to the spigot that apparently caused by an excavator. There was a long score mark along the top of the spigot which ended at the socket which was also damaged. The stress that had been applied to the top of the pipe was sufficient to permanently distort the spigot (Figs. 2 – 3). There was also damage evident on the socket of 00/6 (Fig. 4) that looked like a crowbar or tooth from an excavator had caught the lip of the socket. This did not cause failure in either the pressure or vacuum test. It was observed that many of the pipes exhibited a staining pattern that had the appearance of tree roots in contact with the pipe (Fig.5). The results show that except in the case of the damaged spigot, the joints have maintained their integrity for up to 25 years and continue to meet the infiltration and exfiltration requirements of new pipe as specified in AS/NZS1260.1999

Figure 2. Damaged Sample 00/4.

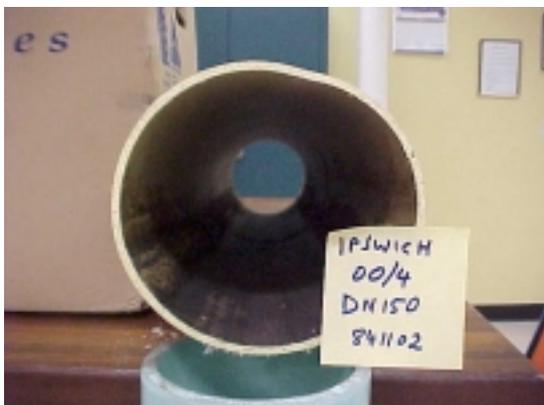
Figure 3. Distortion in spigot of 00/4.

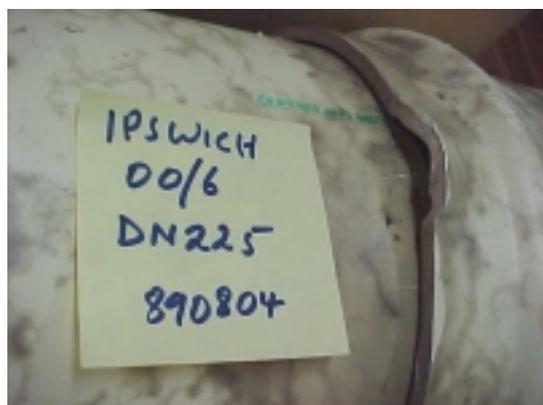
Figure 4. Damage to socket of 00/6.

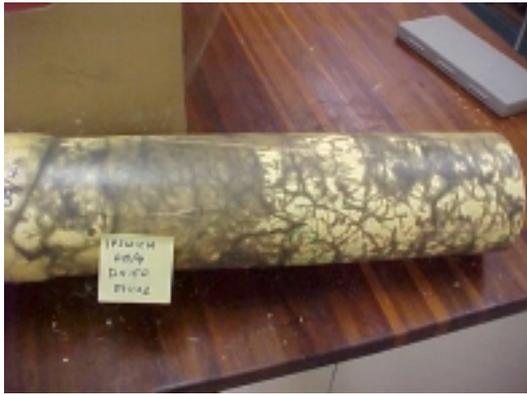
Only the DN225 joints exhibit an interface pressure that meets the minimum requirements of the product Standard, AS1260-1984 (Table 2). That is, an initial interface pressure of not less than 0.55 MPa over a continuous length of at least 7mm. All the DN150 joints, except the damaged 00/4, exceeded the interface pressure of 0.4MPa over at least 4mm, as required by the current version of AS/NZS1260. When the joints were disassembled for the interface pressure test, there was no evidence of microbiological attack on the rubber. Nor was there any suggestion of tree root intrusion despite the external staining pattern that implied tree roots were in close proximity to many of the pipes.

Figure 5. Typical external staining pattern. Figure 6. Wall thickness of individual pipes.

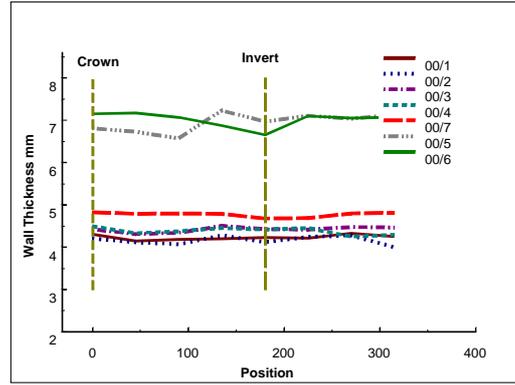
The wall thickness of each pipe, measured around the circumference at 45° intervals was plotted against the circumferential position (Fig 6). It can be seen that whilst there is some variation in wall thickness around the circumference, there is no indication that the wall thickness is systematically lower at the invert. Moreover, there is no suggestion of any difference between the pipes of different ages, as might be expected if there was a loss due to wear. Also, all the pipes still comply with the minimum wall thickness requirements of the appropriate product Standard.

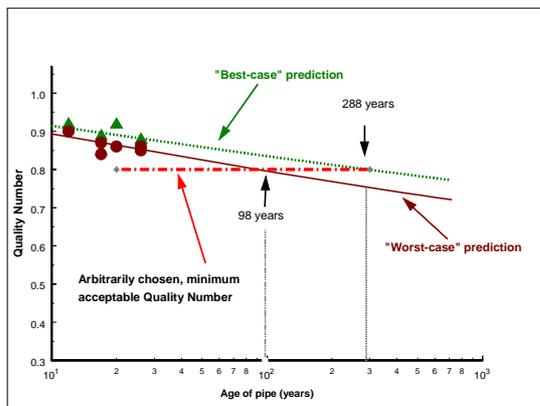
The Quality Numbers for the exhumed pipes versus the number of year's service, are shown in Fig. 7 (a). The graph shows the minimum life expectancy of the PVC pipes tested to be in excess of 98 years. The "best value" weighting factors give a more optimistic predicted service life of almost 300 years. It should be noted that the number of samples tested is only seven and the program should be continued in order to predict the life expectancy with an even greater confidence.

Figure 7 (a) Judgemental approach. Figure 7 (b) multivariate regression analysis. Quality Number versus Years of Service.

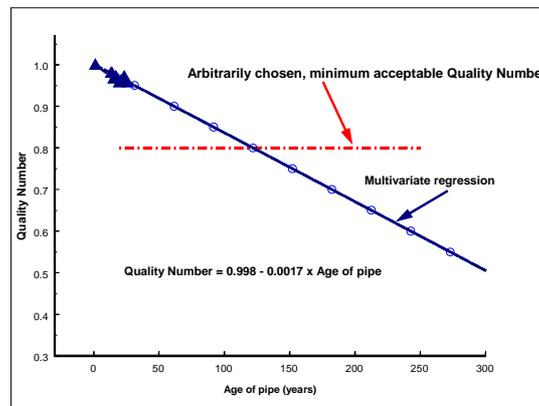
Linear multivariate regression analysis has been applied to the test results and an alternative prediction of service life determined (Fig. 7 (b)). In this analysis, the ratios of *Measured Parameter:Reference Value* for the characteristics in Table 7 were used as independent variables and linear multiple regression analysis was undertaken with *Age* as the dependant variable. This analysis supports the outcome of the judgemental analysis.
