# TP006 LONG TERM PERFORMANCE OF PVC PRESSURE PIPES

ISSUE 01 / AUGUST 2012

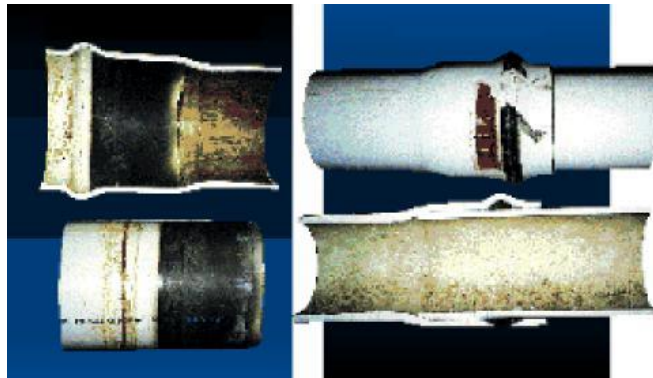
Polidex Rubber Ring Joint Rubber Ring Joint

Elastomeric seal joints as exhumed and subsequently sectioned are depicted below.

Dark staining is evident on the matching socket and spigot surfaces where the water would be essentially dormant. This staining is likely to be due to sulphides reacting with the lead stabiliser in the pipe. The staining is only a surface effect.
