TNO Science and Industry

Introduction

development of reliable methods for prediction of residual lifetime of PVC water distribution systems based on a thorough understanding of underlying degradation processes which is accepted within PVC pipe industry and PVC water pipe users

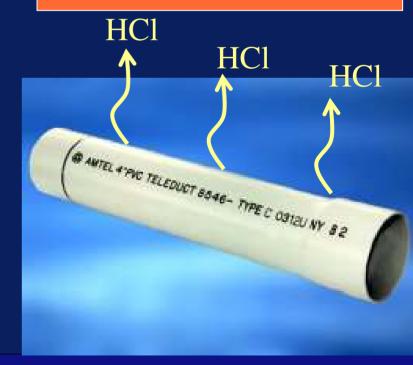
- Degradation mechanism:
 - Dehydrochlorination and thermo-oxidation
 - HCl is released influenced by thermal energy
 - Slow in service at 15 °C
 - Fast during processing at 200 °C
- Consequence:
 - Embrittlement
 - Discoloration
- Chemical physical checks:
 - K-value
 - residual amount of stabiliser
 - concentration of vinyl group

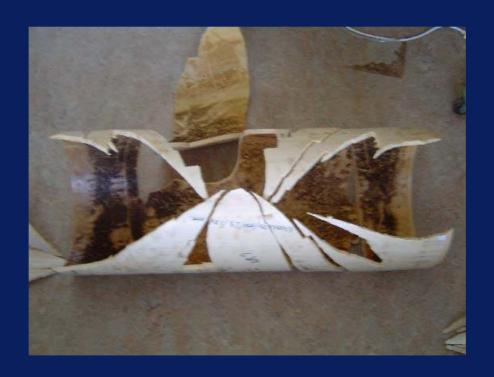
• Pipes are hydrostatically pressurised and the time until failure is monitored

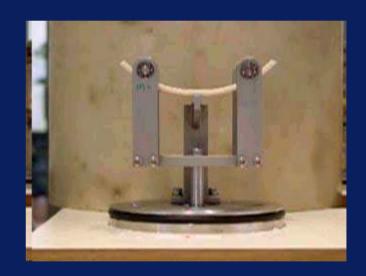
- Ring segment is notched and subjected to three point bending
- The time until failure is monitored versus applied stress

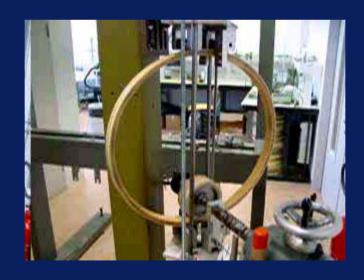
- Loaded ring is rotated
- Number of cycles until failure is monitored versus stress level applied
