# Water Main Break Rates In the USA and Canada: A Comprehensive Study

An Asset Management Planning Tool for Water Utilities

Utah State University  
Buried Structures Laboratory  
Steven Folkman, Ph.D., P.E.

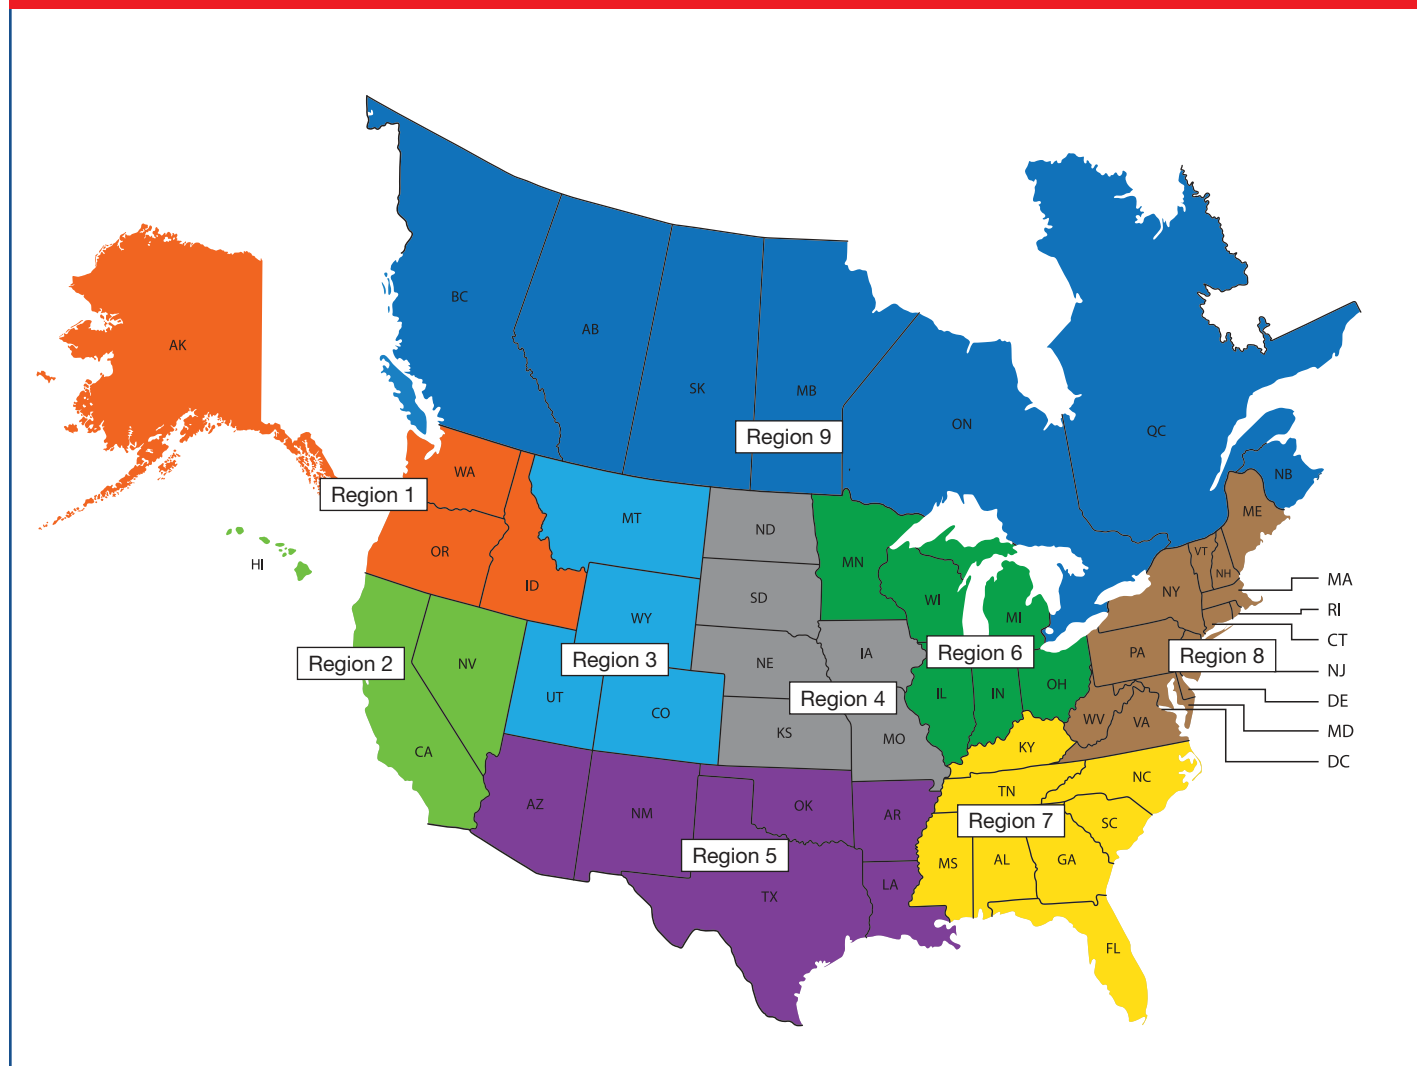
**FIGURE 1: REGIONS USED TO REPORT SURVEY RESULTS**

In total, 281 utilities participated in the surveys and provided failure data. To examine regional variations, nine survey regions in the United States and Canada were selected. The regions defined in the study are used here to indicate the wide geographical distribution of the respondents. Table 1 lists the number of respondents with failure data, the miles of pipe, and the population served in the basic and detailed surveys from each region. Figure 1 illustrates the locations of the nine different regions used in this report. Respondents were asked to report the length of water supply mains in their system but not to include sewer or force mains or lines with a diameter less than 3 inches. Figure 2 illustrates the miles of water main pipe that were reported in the basic and detailed surveys on a regional basis. A total of 170,569 miles and 98,097 miles of pipe was reported by respondents in the basic and detailed surveys, respectively. Figure 3 illustrates the number of respondents from each region. There were 26 additional respondents to the basic survey that could not provide failure data and these are not included in the miles of pipe or populations served in Table 1. The respondents are distributed across a large survey area. The basic survey

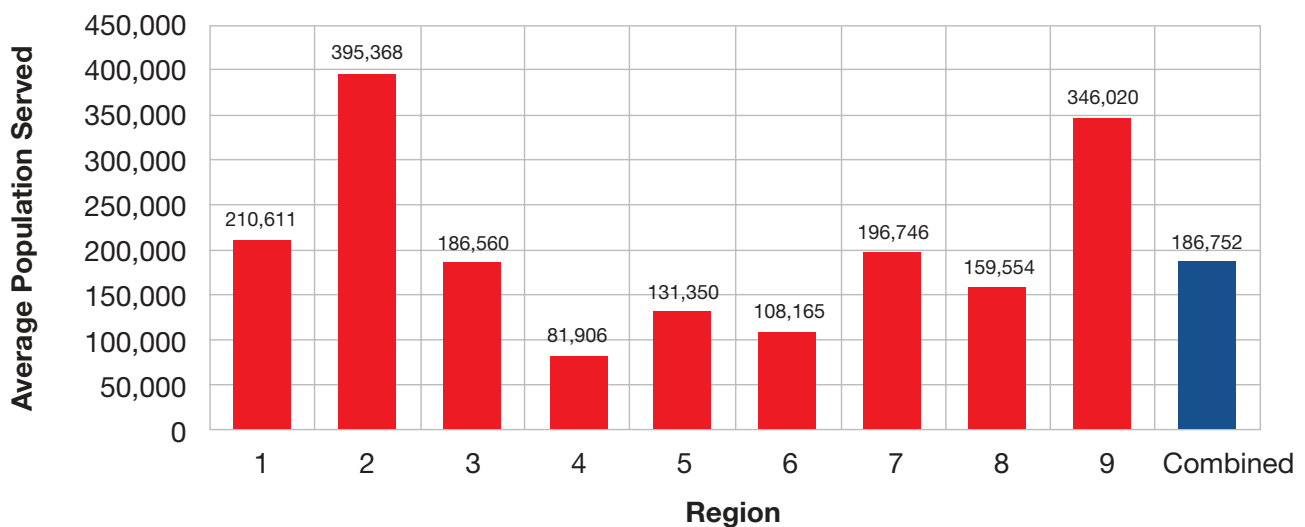
**FIGURE 5: AVERAGE POPULATION SERVED FROM EACH REGION RESPONDING TO THE BASIC SURVEY**

Figure 5 shows the average population served per utility for each region in Figure 1. The average population served per utility for the entire basic survey was 186,752.

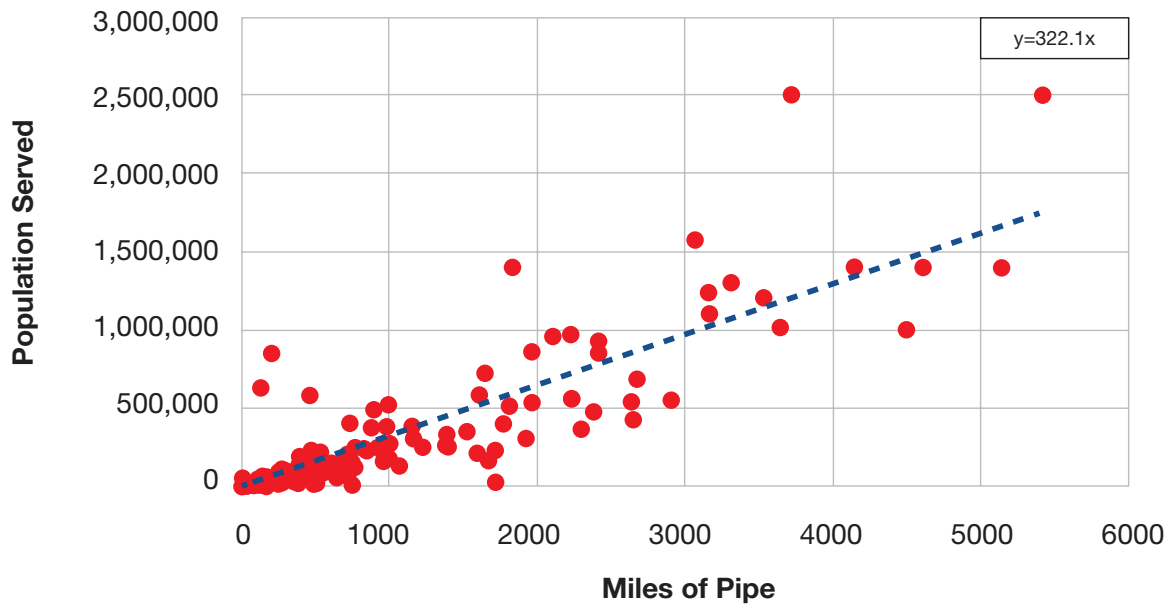
**FIGURE 7: POPULATION SERVED RELATIVE TO TOTAL MILES OF PIPE FROM THE BASIC SURVEY**

Figure 7 illustrates the relationship between the population served by the utilities participating in the basic survey and the number of miles of water main pipe. The trend line and equation are a best fit to the data. The slope of this line indicates that there are on average 322 people served for each mile of water main installed. Figure 7 tends to be biased by the points most distant from the origin. Figure 8 utilizes the data in Table 1 to compute average population served per mile of pipe for each region. We see that this produces an overall average of 308 people served per mile. More rural areas such as Regions 3, 4, and 5 have lower population to miles of pipe ratios as expected. Utilities that were exclusively transmission systems were excluded. This compares with a commonly used estimate of 325 people per mile (Eidinger, 2001). The 2012 survey reported this value as 264 people served per mile. Pipe breaks in utilities with a higher count of people per mile would have a greater impact on the community.

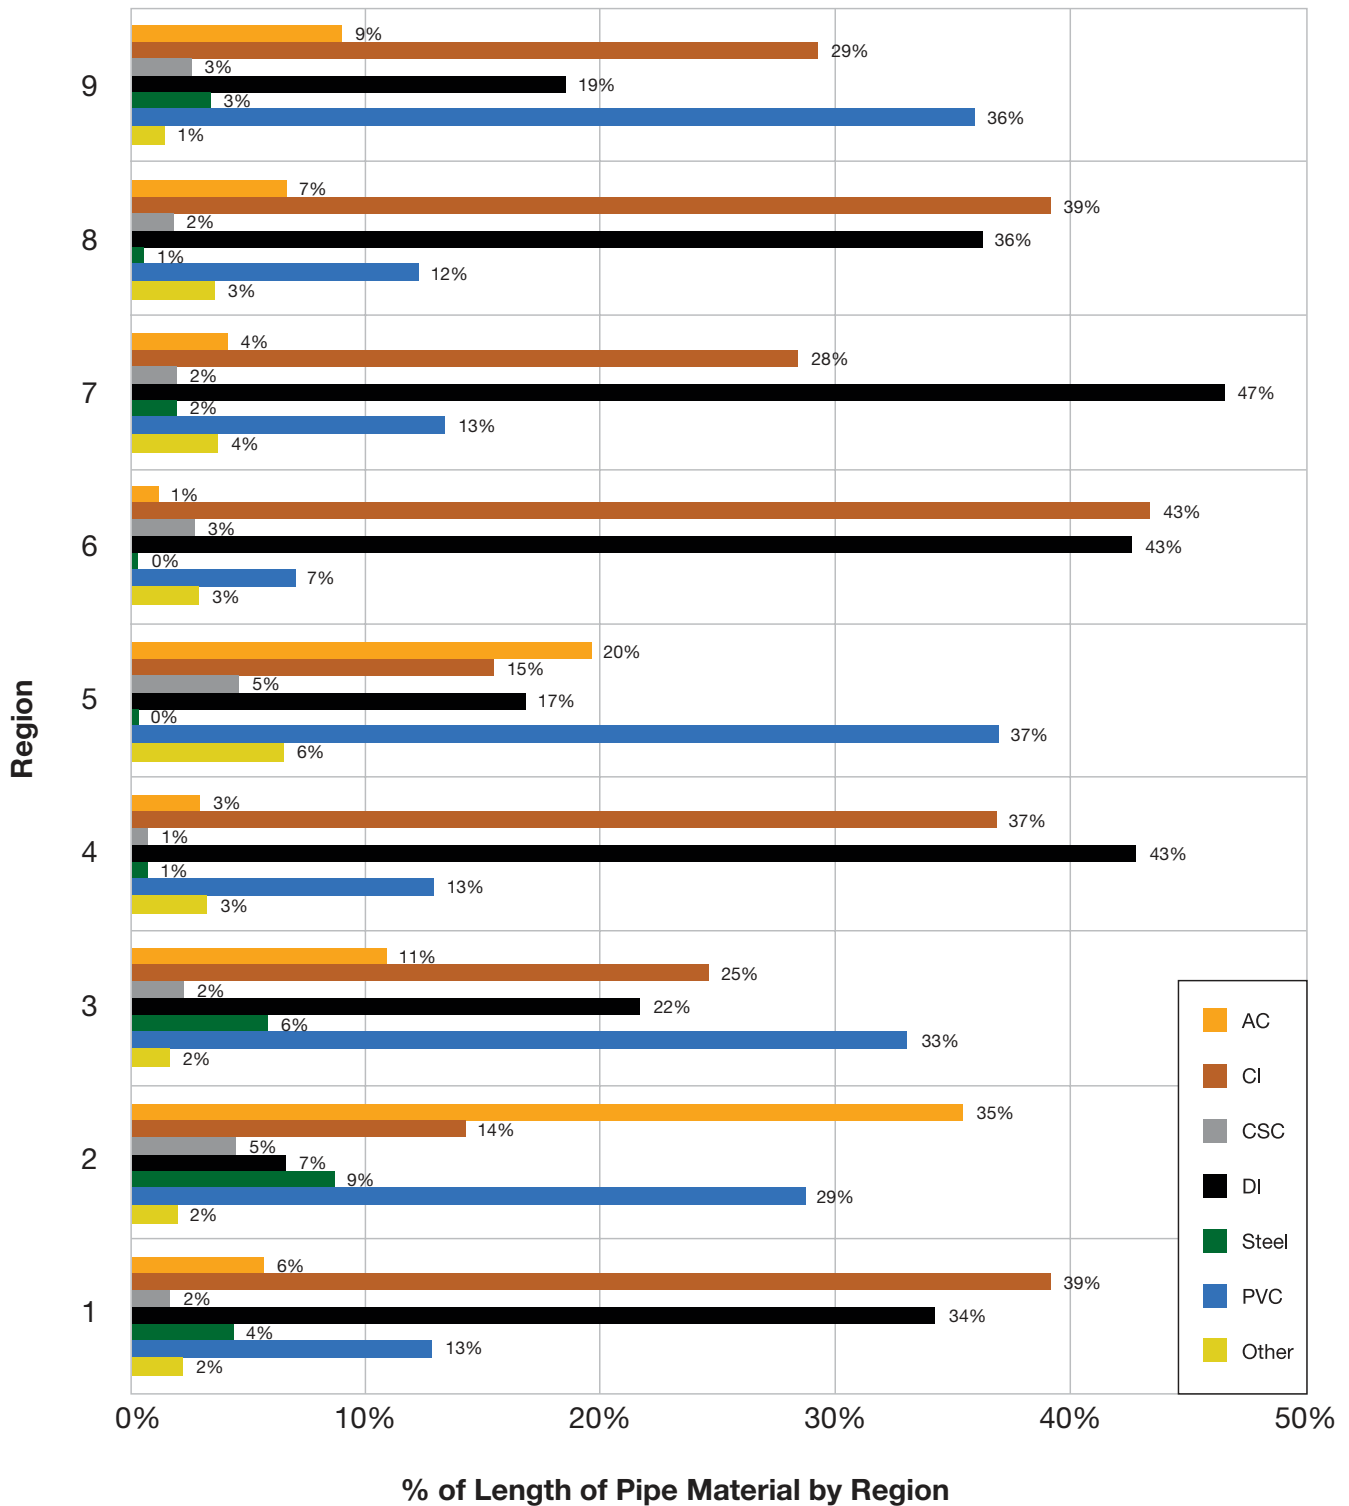
**FIGURE 11: REGIONAL PERCENTAGE OF LENGTH OF PIPE BY MATERIAL TYPE (BASIC SURVEY)**

Figure 11 illustrates the regional distribution of pipe material usage as a percentage of the total length in that region. It is interesting to note the significant differences in regional pipe material utilization. Cast iron (CI) and ductile iron (DI) pipe represent approximately 86% of the water mains in Region 6 and over 75% in Regions 4, 7, and 8. PVC has a leading role in Regions 3, 5 and 9 and is slightly behind asbestos cement (AC) pipe in Region 2. AC pipe has a significant presence in Regions 2 and 5. Region 2 is unique in that it is the only region where AC pipe is the most common material. This suggests that the selection and use of pipe materials are based on historical preference versus comparative cost analysis or environmental conditions. Since CI and AC pipes are no longer manufactured in the US and Canada, the use of these materials in water systems should be decreasing with time as they are replaced. By applying asset management best practices, life cycle cost analysis should be used to do a comparative total cost of ownership evaluation of what pipe material should replace the CI and AC pipes.

Water main pipe material usage varies significantly over geographic regions (see Figure 11). This suggests that the selection and use of pipe materials are based on historical preference versus comparative cost analysis or environmental conditions. The upper northwest and eastern half of the USA (Regions 1, 4, 6, 7, and 8 as illustrated in Figure 1) have either cast iron or ductile iron pipe for much of the installed pipe length. Regions 3, 5, and 9 have more PVC pipe than any other material. The most common pipe material in Region 2 is asbestos cement and it is unique in that respect.

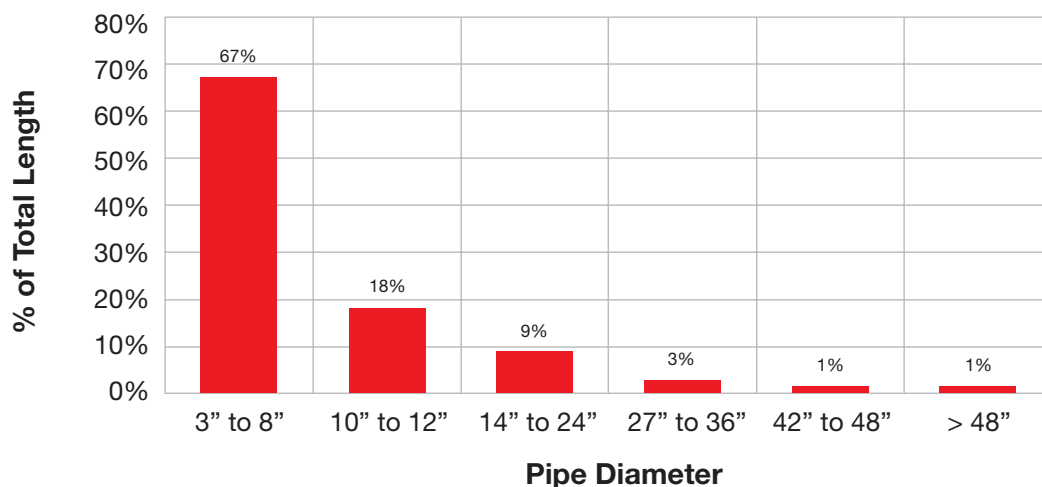
**FIGURE 15: PERCENT OF TOTAL LENGTH OF PIPE BY SIZE FROM THE DETAILED SURVEY**

The detailed survey respondents were also asked to break down the fraction of total installed pipe length by six pipe diameter categories. Figure 15 illustrates the percentage of water main that fit into each size range. Figure 15 indicates that approximately 67% of the installed pipe is 8 inches or less in diameter. The 2012 survey found that 66% of the pipe was 8 inches or less in diameter showing good agreement. Earlier studies assumed 73% of water pipes were 10 inches or less in diameter (Stone et al., 2002). Figure 16 illustrates the diameter distribution for each material type. Figure 16 shows that large diameter transmission pipes are dominated by steel and concrete pipe materials with 18% of all concrete pipe and 14% of all steel pipe having a diameter greater than 48-inches. Figure 17 illustrates the percent of total length of all pipe materials broken down by material type and diameter. Figure 17 illustrates that cast iron pipe from 3 to 8 inches in diameter represents over 19% of the installed pipe.

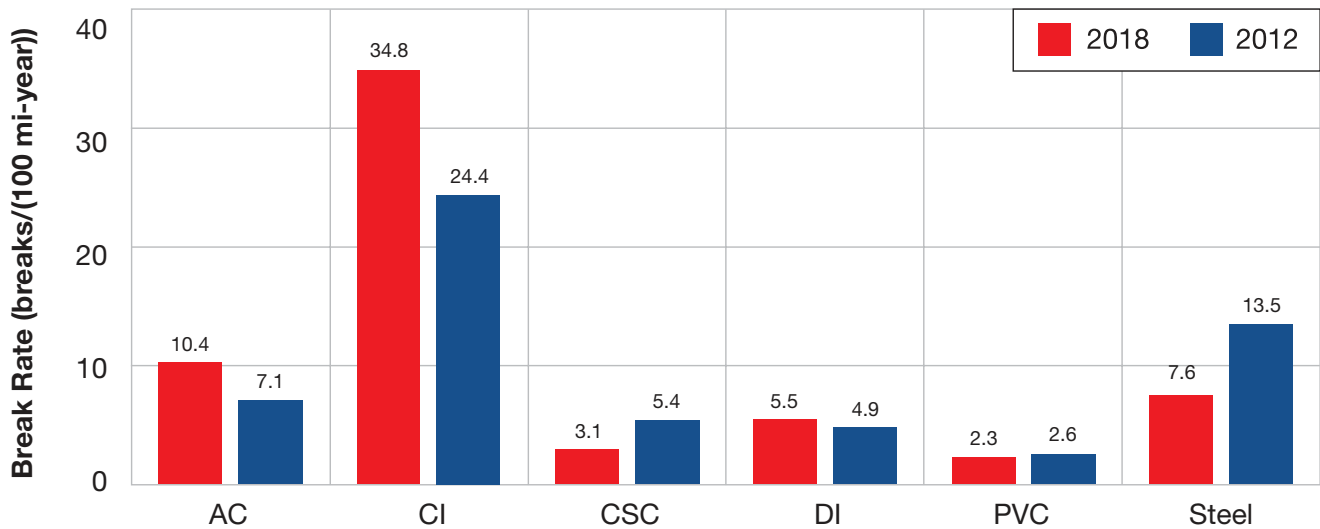
**FIGURE 22: COMPARISON OF BREAK RATES OF THE 2018 AND 2012 SURVEYS**

Figure 22 compares the break rates of the 2012 and 2018 surveys. Since over 90% of installed pipe consists of AC, CI, DI, and PVC, the break rates for those material types will be most accurate. From 2012 to 2018, Figure 22 shows a small decrease in break rates for PVC and a small increase for DI pipe. The overall consistency of those values demonstrates they are accurate. Again, the increase in break rates for AC and CI pipes is a very significant observation.

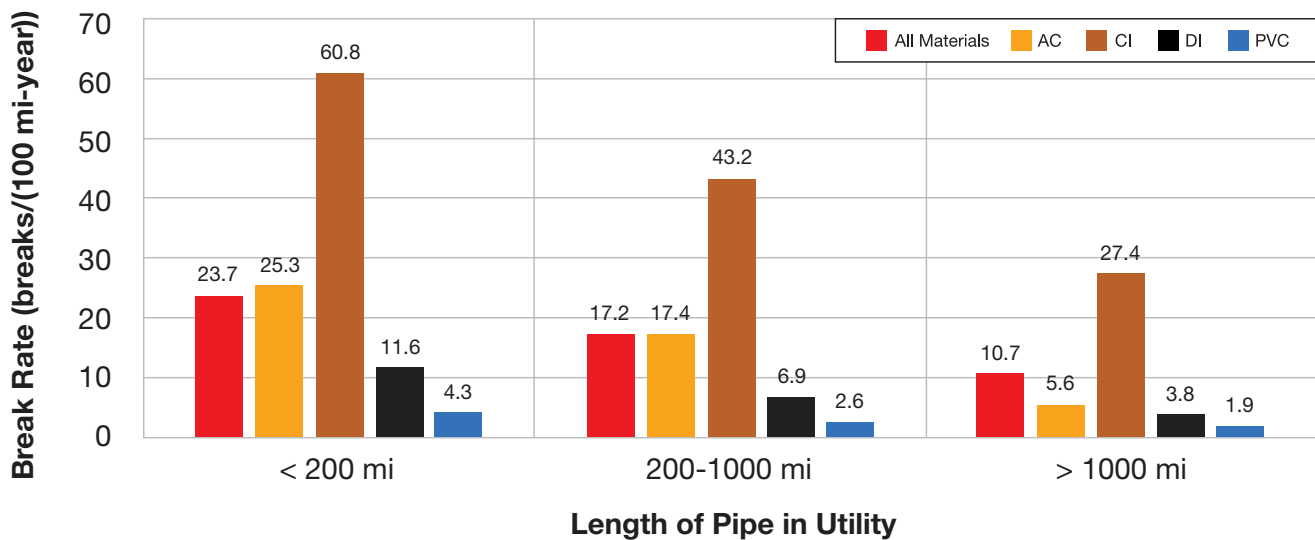
**FIGURE 23: BREAK RATES BY UTILITY SIZE FROM THE BASIC SURVEY**

The size of a utility can affect break rates. Three sizes of utilities are considered here based on the length of pipe; small with less than 200 miles, intermediate with 200 to 1000 miles, and large with over 1000 miles. Figure 23 illustrates the overall break rate (for all pipe materials) and then separated by the four most common pipe materials in these three utility sizes. The large utilities consistently had lower break rates than intermediate and smaller utilities. This is likely due to better funding and larger staffs for engineering design, monitoring and information gathering, installation oversight, and repair of water mains. It is very significant that small utilities consistently have break rates at least double that of a large utility.

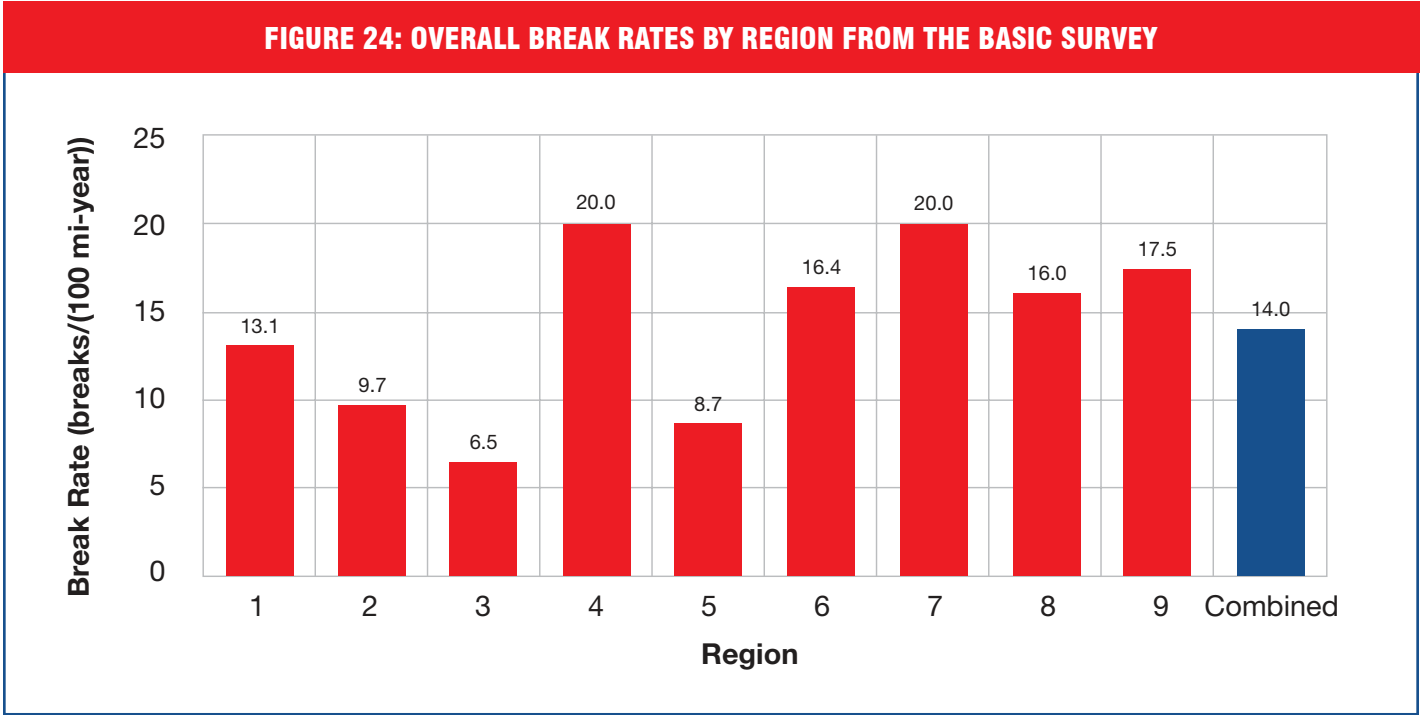
Figure 24 illustrates the overall break rate broken down by region. Clearly not all regions are experiencing the same failure rate. In Table 1, the number of respondents for each region is reported. It was desired to separate US and Canadian break rate data. This is illustrated in Figure 25. Canada can have very corrosive soils (Seargeant, 2013) and this is reflected in the high break rates of cast and ductile iron pipes in Figure 25. Seargeant reported that the highly corrosive soil in Edmonton necessitated a transition from cast iron to asbestos cement pipes in 1966 and then to PVC starting in 1977. The transition to PVC has produced a dramatic reduction in water main break rates for the city.

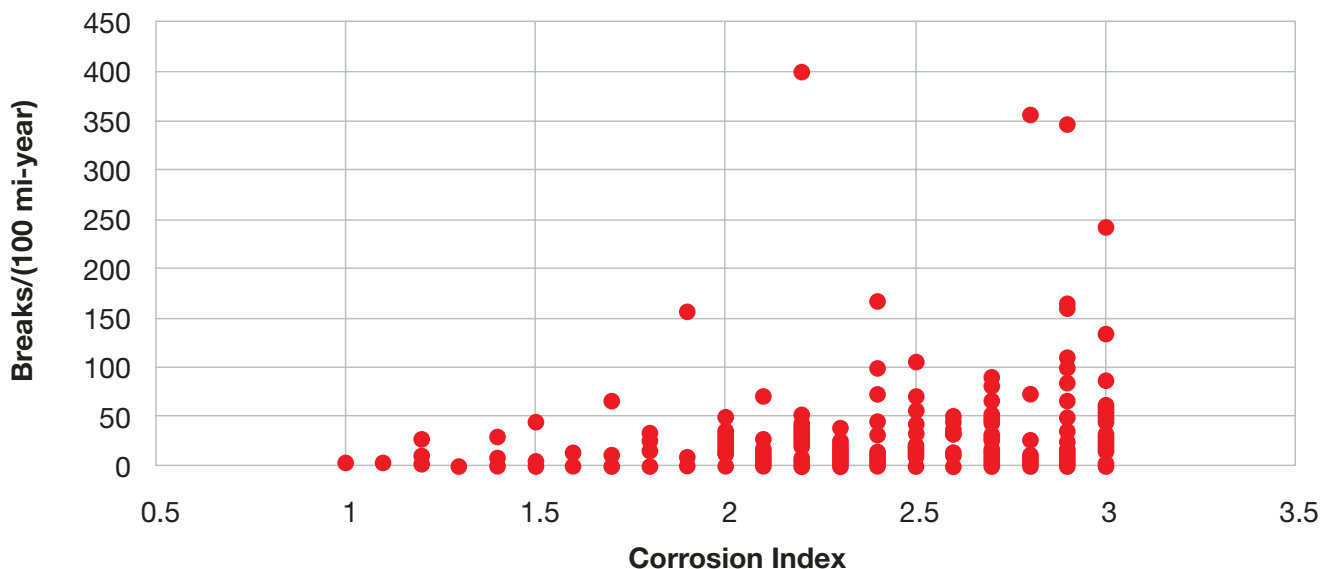
**FIGURE 33: INDIVIDUAL UTILITY BREAK RATES FOR CAST IRON PIPE VERSUS THEIR CORROSION INDEX**

It is reasonable to expect break rates would increase when pipe is installed in corrosive soils. To examine this, plots were made of a utility's corrosion index versus break rate. Figure 33 illustrates this for cast iron pipe. There is a trend of higher break rates with increasing corrosion index, but the wide scatter in the data makes analysis difficult. The high break rates in Figure 33 are associated with small utilities that have a small amount of pipe. Consider a utility with 1 mile of cast iron pipe with 2 breaks during the past year. That would translate to a break rate of 200 breaks/(100 miles)/year. If that utility had no breaks the following year, the break rates drop to zero.

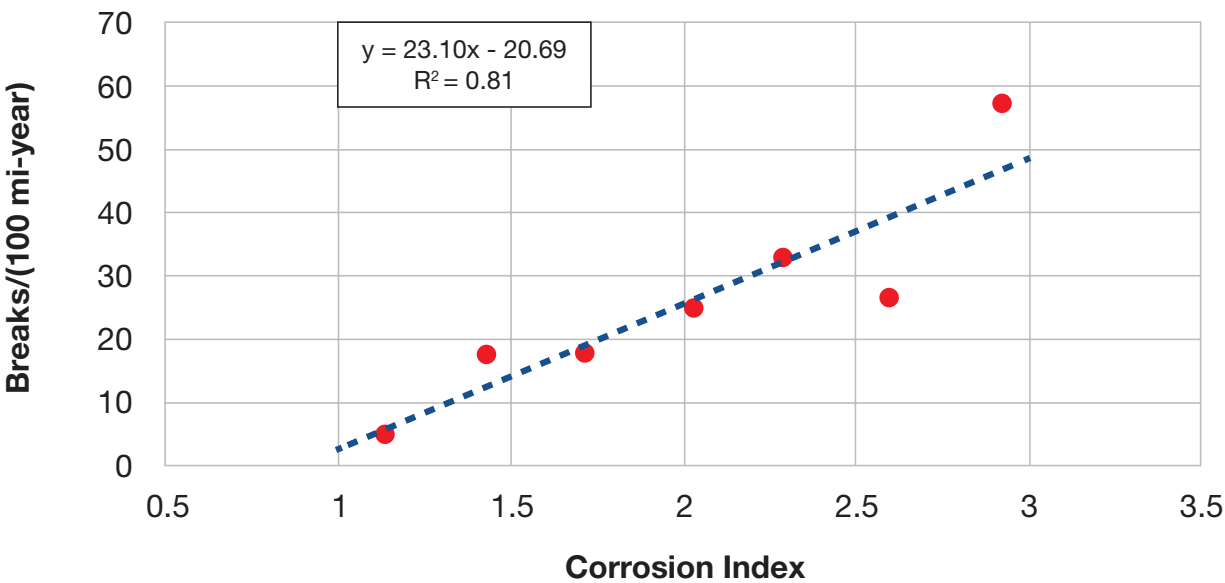
FIGURE 34: CAST IRON PIPE BREAK RATE VERSUS CORROSION INDEX

To get a realistic estimate of break rates, we need to add the number of breaks of a pipe type from several utilities and divide by the sum of the length of that pipe type to compute break rates. The corrosion index data was broken down into the same seven categories used in Figure 32. The results are listed in Table 7. The break rates versus corrosion index data are plotted in Figure 34 for cast iron pipe and Figure 35 for ductile iron pipe. The figures also contain a regression equation fit and a correlation coefficient. Correlation coefficients close to 1.0 indicates an excellent correlation and zero indicate no correlation. Both cast and ductile iron results in reasonably good fits to the data.

Analyses of soil corrosivity completed in this study shows that a cast iron (CI) pipe in highly corrosive soil is expected to have over 20 times the break rate of a CI pipe in low corrosive soil. Traditionally, the thickness of the iron pipe wall provided the additional corrosion protection. CI pipes manufactured after World War II have significantly higher failure rates due to thinner walls. The resulting higher main

Using the equations in Figure 34 with  $x=1$  for a low corrosion risk and  $x=3$  for a high corrosion risk, one can show that a cast iron pipe in a high corrosion soil is expected to have over 20 times the break rate of one in a low corrosion soil. Similarly, ductile iron pipe in a high corrosion soil has over 10 times the break rate than one in a low corrosion soil. Very poor correlations were found for the other material types in this survey.

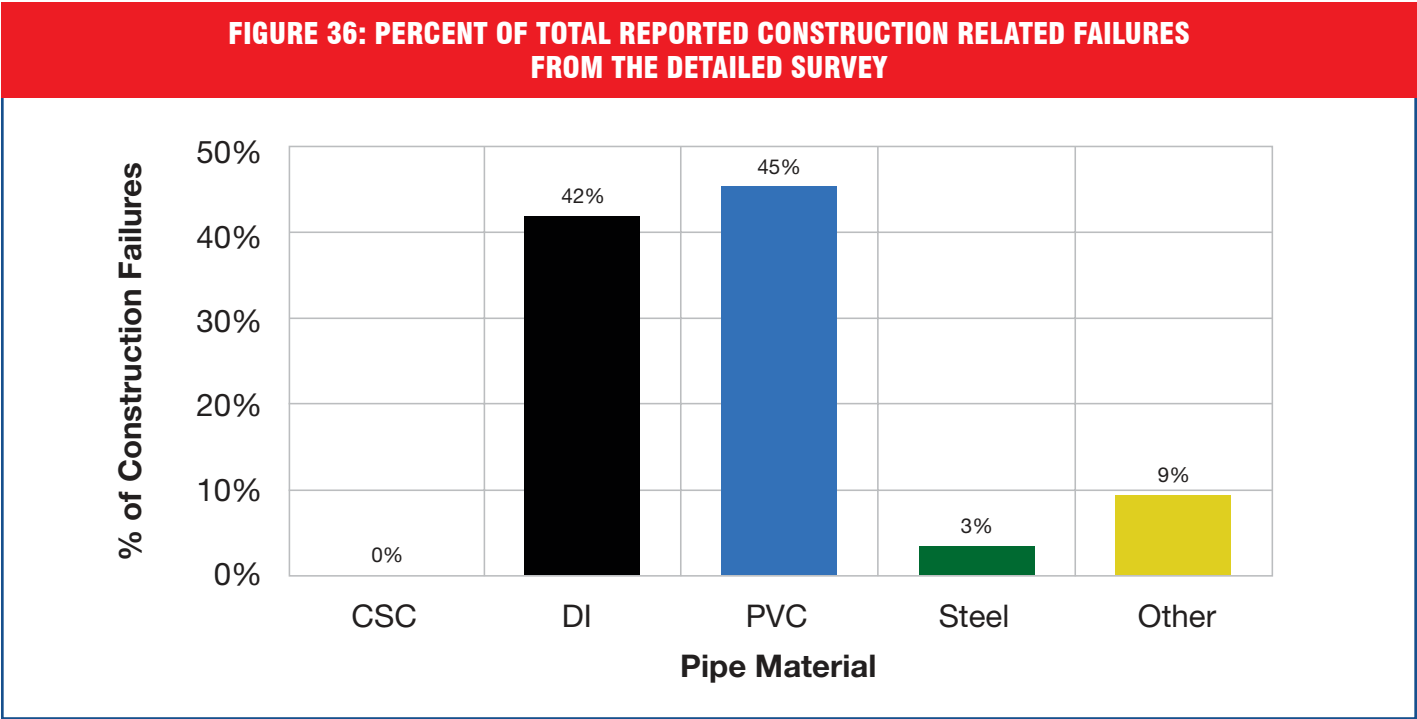
The detailed survey asked respondents to report failures related to construction activities. Figure 36 illustrates the percentage of total construction failure related to a particular pipe material. Ductile iron and PVC pipes have the majority of construction related failures at a nearly equal frequency. Figure 14 shows that DI and PVC are the two pipe materials that are also most commonly being installed today. This points to the need to improve construction practices for underground infrastructure regarding installation, location services and inspection.

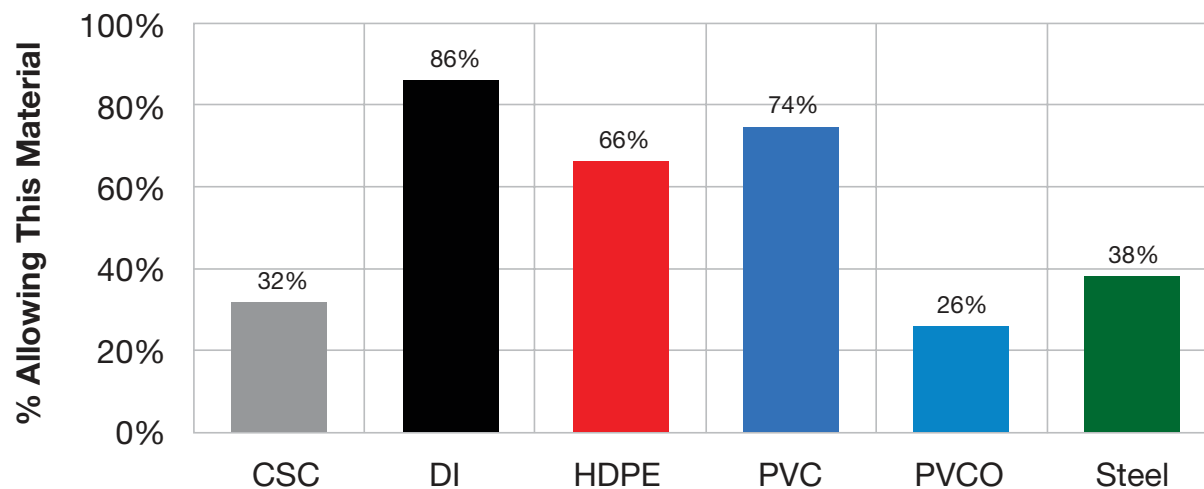
**FIGURE 39: RESPONDENTS ALLOWING INSTALLATION OF THESE WATER MAIN MATERIALS**

The detailed survey also asked respondents what water main pipe materials are currently approved for use at their utility. Figure 39 illustrates the percentage of respondents that allow a particular pipe material to be installed. HDPE pipe at 66% allowance for use in water systems represents a high degree of acceptance for trenchless applications such as pipe bursting and directional drilling, whereas for open cut installations PVC and ductile iron pipe are the predominantly accepted materials (see Table 10). Figure 40 compares the pipe materials approved for use by utilities in the 2018 survey with the data obtained in the 2012 survey. Figure 40 shows a 23% increase in the acceptance of PVC water pipe by North American utilities since 2012. Specifically, PVC pipe approval among survey respondents increased from 60% of water utilities allowing its use in 2012 to 74% of utilities allowing its use in 2018. The number of utilities approving of ductile iron, concrete steel cylinder, and steel pipes for use in water systems remains essentially the same.
