Quality assessment of the PVC gas grid in the Netherlands

René Hermkens, 17 September 2019 Bologna

Kiwa Technology

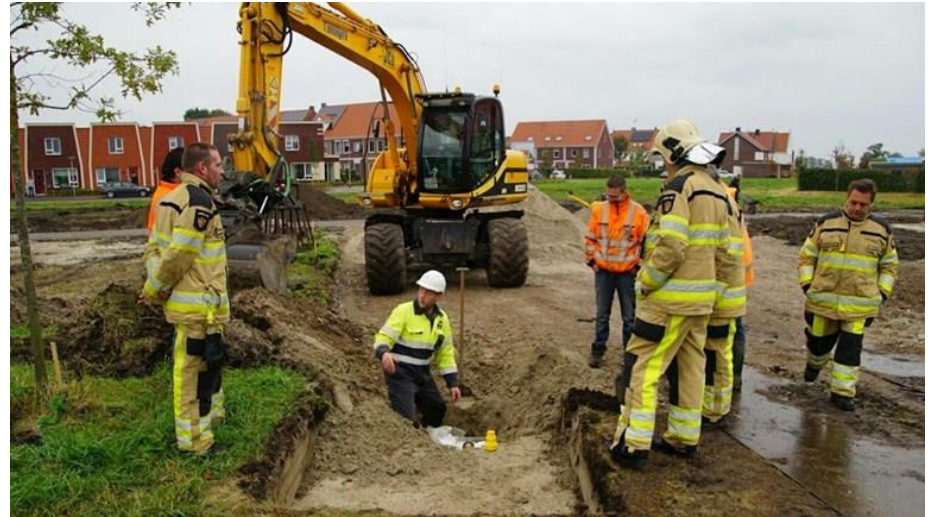
Assessment of the PVC-grid

Age PVC-U grid: > 45 years

Question: Is replacement necessary?

- Internal gas pressure: 30 or 100 mbar
-> Strength not an issue
- Lifetime limiting failure mode PVC gas grid:
 - No slow crack growth observed
 - Main failure cause: third party damage
-> Impact resistance most important

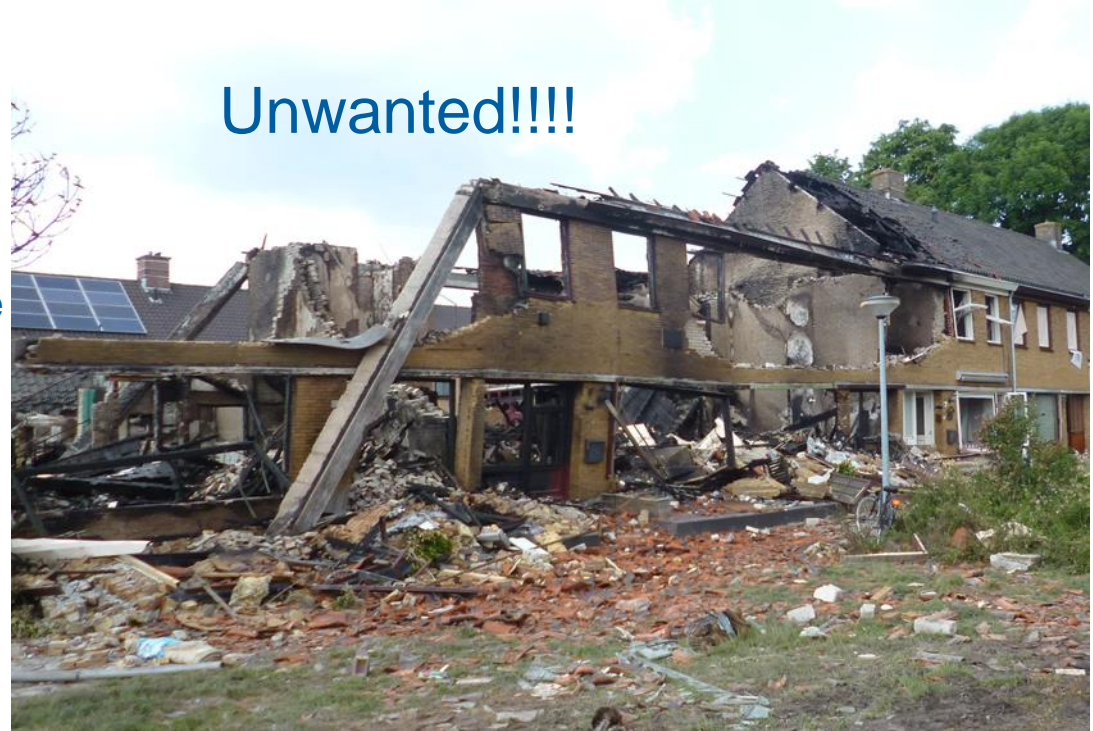
Impact resistance and failure modes

Brittle failure:

- High gas outflow
 - No time to detect and repair leak
 - High chance of explosion or fire
- Repair difficult (sawing)

Ductile failure:

- Limited to no gas outflow
 - Ability to detect and repair leak
 - Low chance of fire

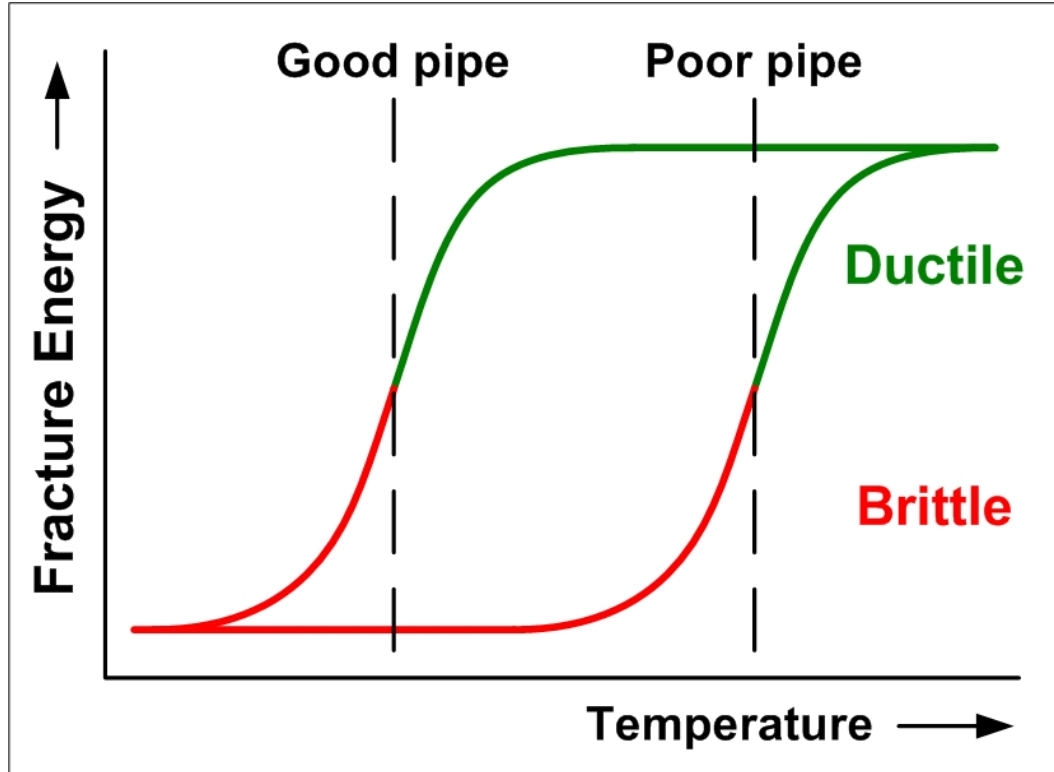
Measuring impact resistance

Brittle-ductile-transition-temperature (T_{bd}): 50% brittle, 50% ductile

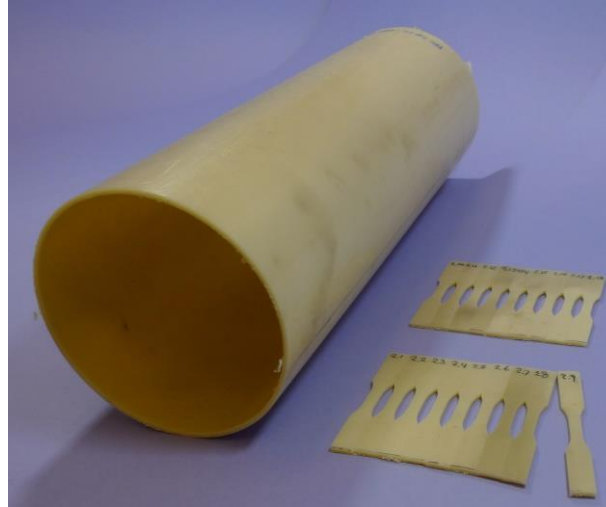
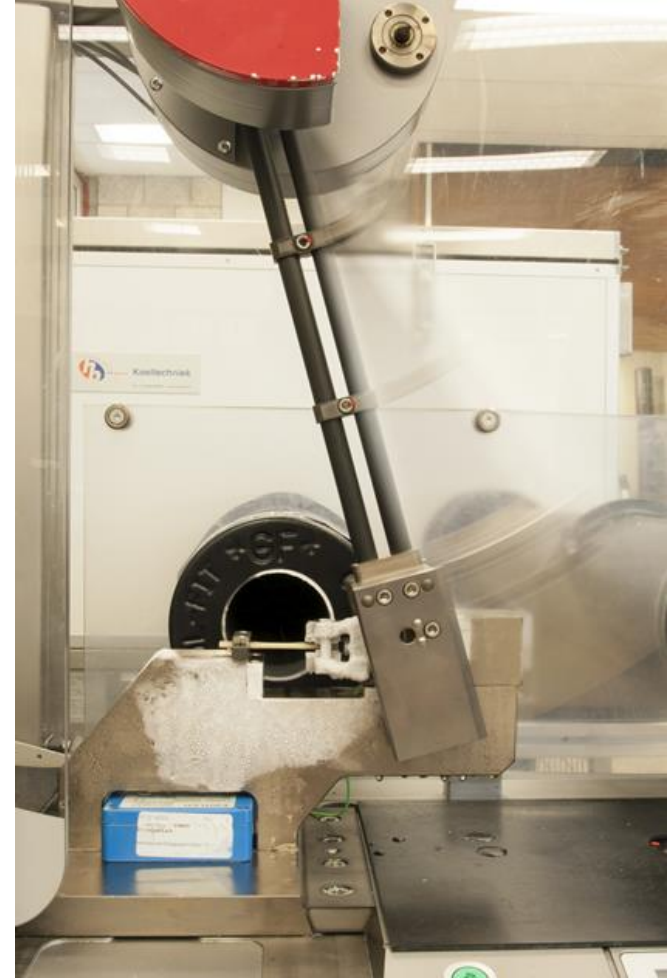
Experimental setup

New test method developed:

- Instrumented impact tester

- Modifications:

- Temperature range:
-25°C to +47,5°C
- Random test bar selection from pipe
- Optimization of the number of test bars and test bar shape: 30 test bars (Dumbbell shape)

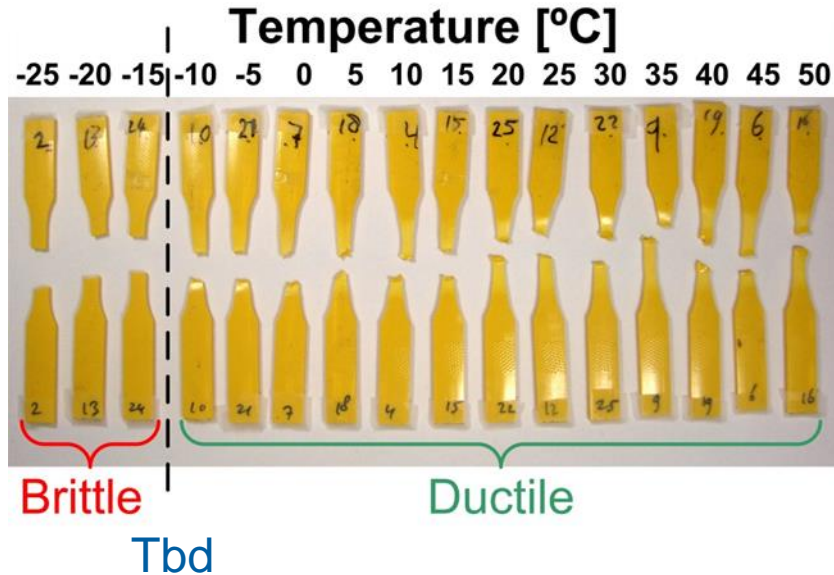
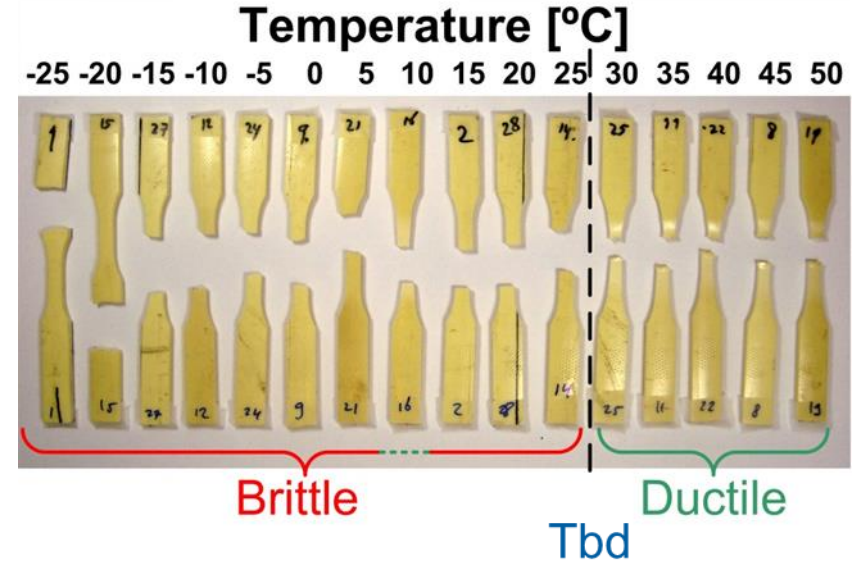
Measuring Tbd

Visual compare of good (left) and poor (right) quality PVC pipe

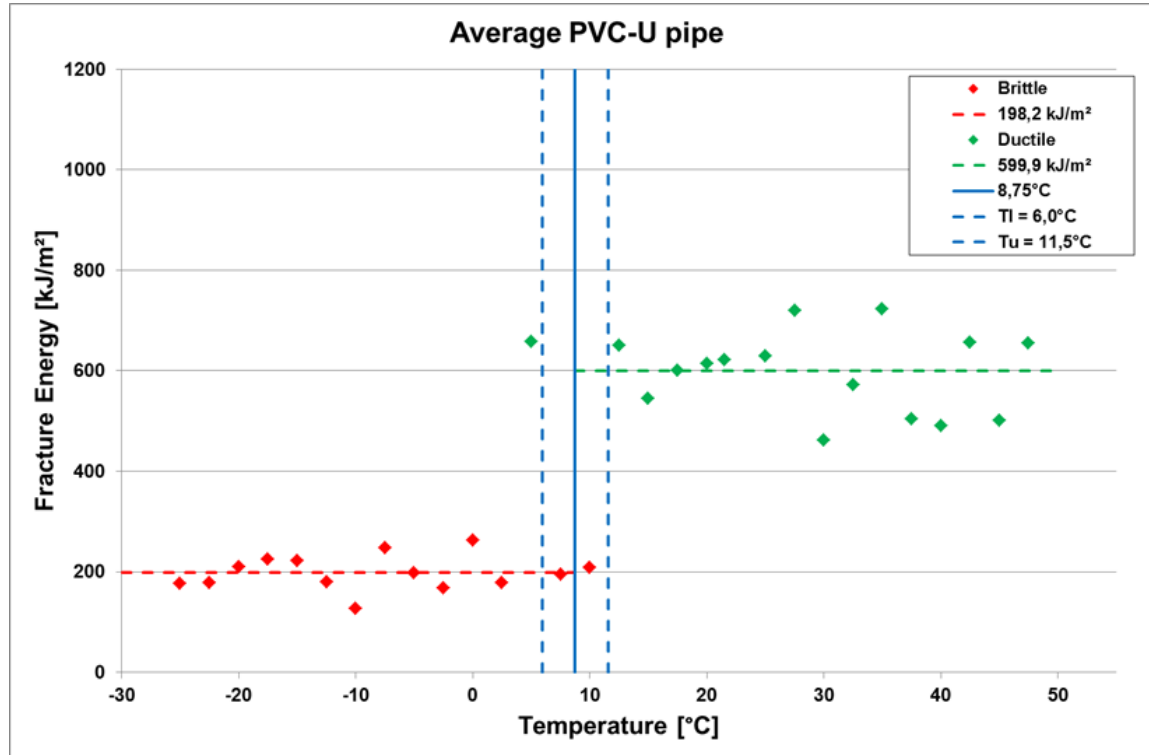
Measuring Tbd: results

An average PVC-U pipe with a T_{BD} of 8,75°C

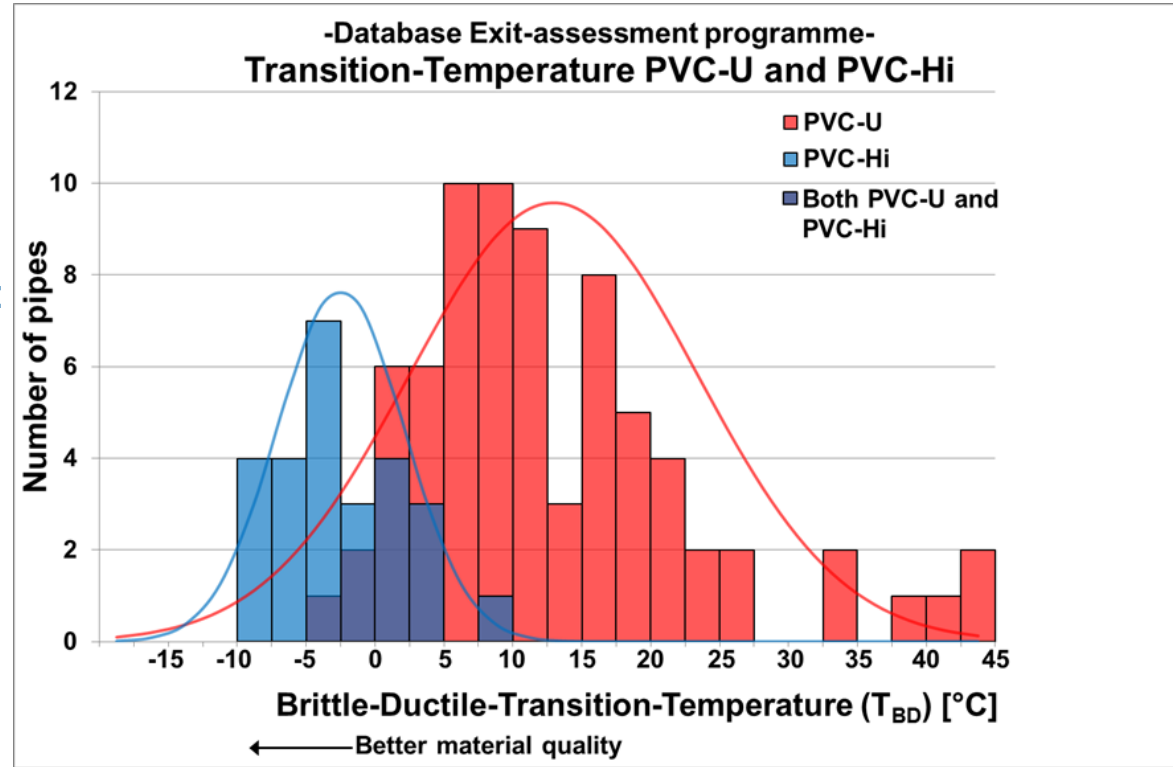
Results Exit assessment programme

- Annually 15 samples of both PVC-U and PVC-Hi
- Additional information from distribution system operator on:
 - Installation date
 - Dept of installation
 - Type of installation
 - Ground water level
 - Et.cetera

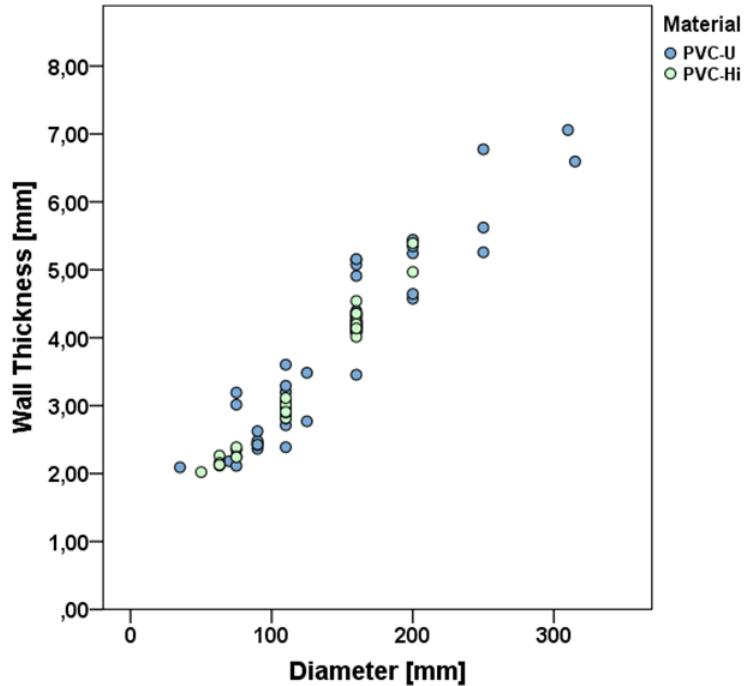
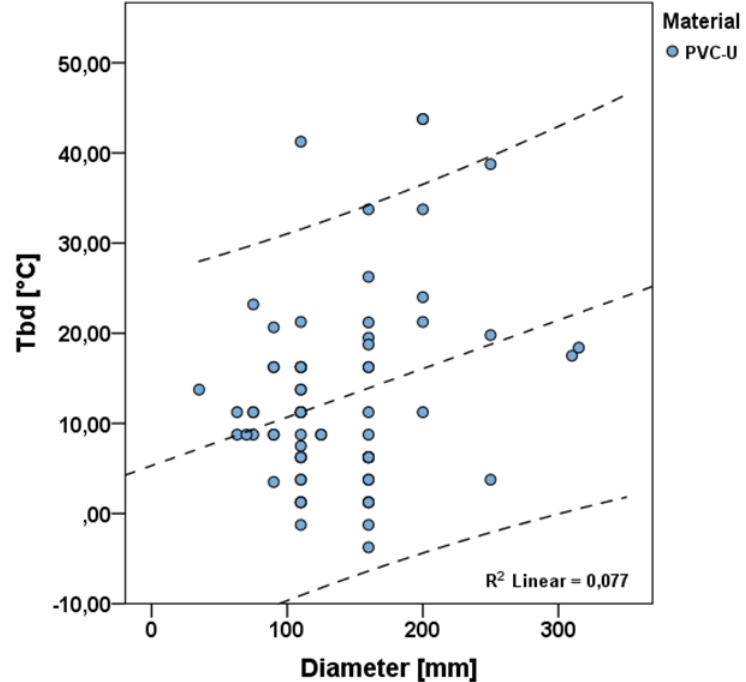
Effect of wall thickness on impact resistance

Trend between the brittle-ductile-transition-temperature (T_{BD}) and the diameter of old PVC-U pipes (right) and relation between wall thickness and diameter of the pipe (left).

- The improved impact test is able to distinguish sub populations of PVC pipes in the Dutch gas grid, based on material quality.
- The DSOs can use this information to optimize their replacement prioritization
- A larger diameter and therefore a thicker pipe wall seems to negatively influence the material quality of PVC-U by elevation the T_{BD}
- PVC pipes which are produced later in time have a better material quality
