Quality assessment of the PVC gas grid in the Netherlands

René Hermkens, 17 September 2019 Bologna

Kiwa Technology

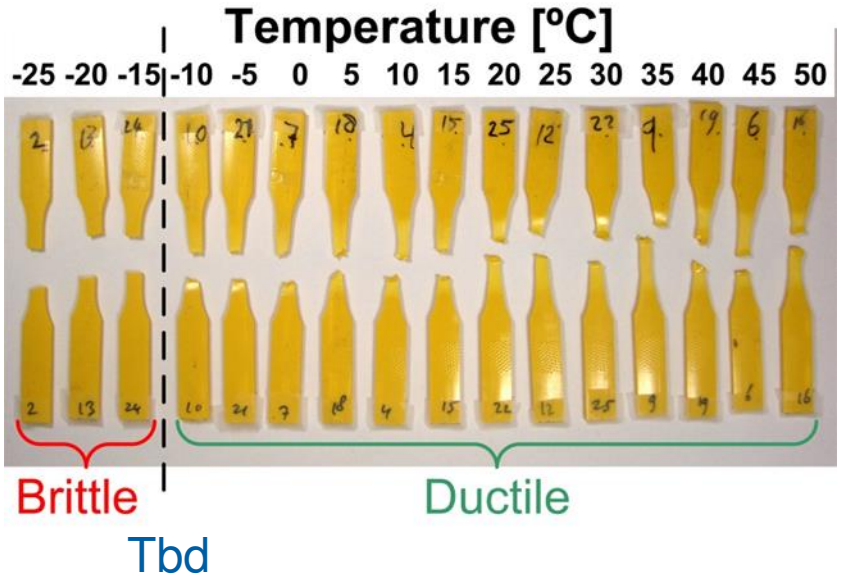
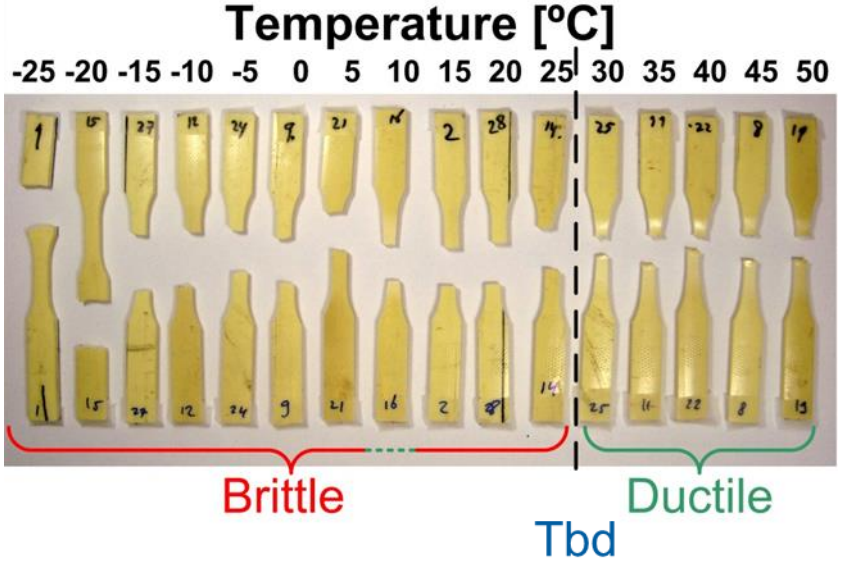
Visual compare of good (left) and poor (right) quality PVC pipe

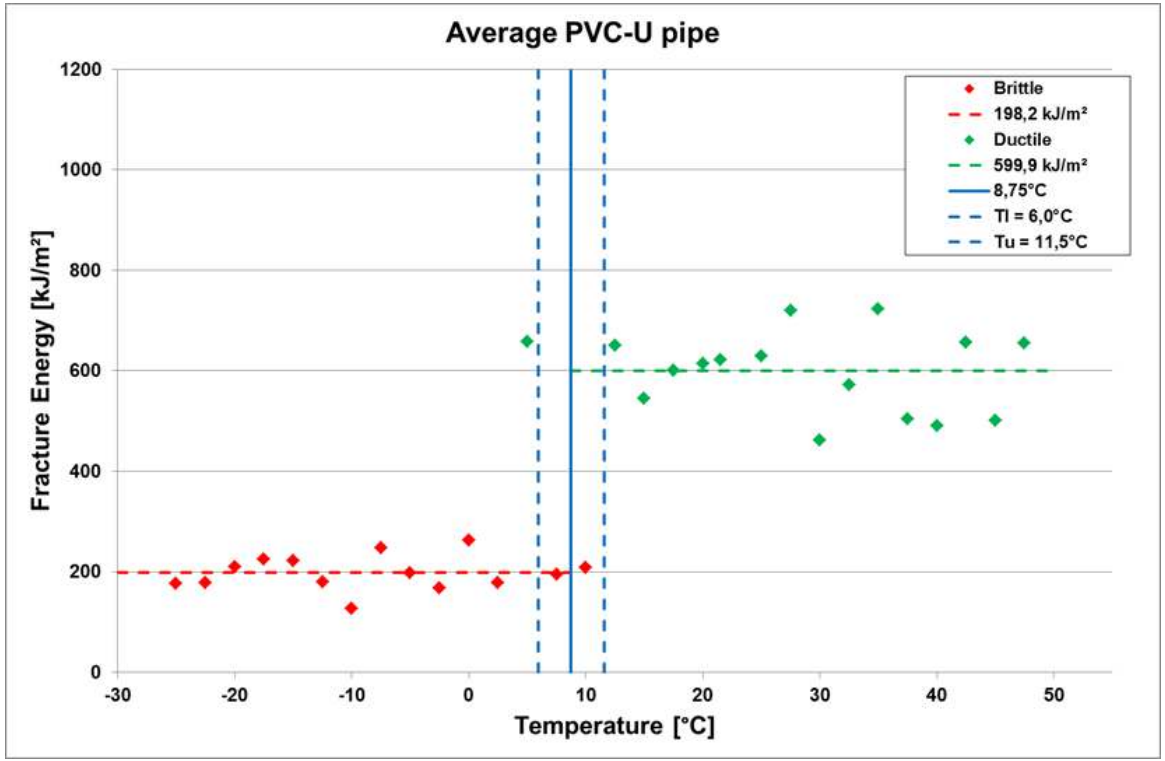
An average PVC-U pipe with a T_{BD} of 8,75°C

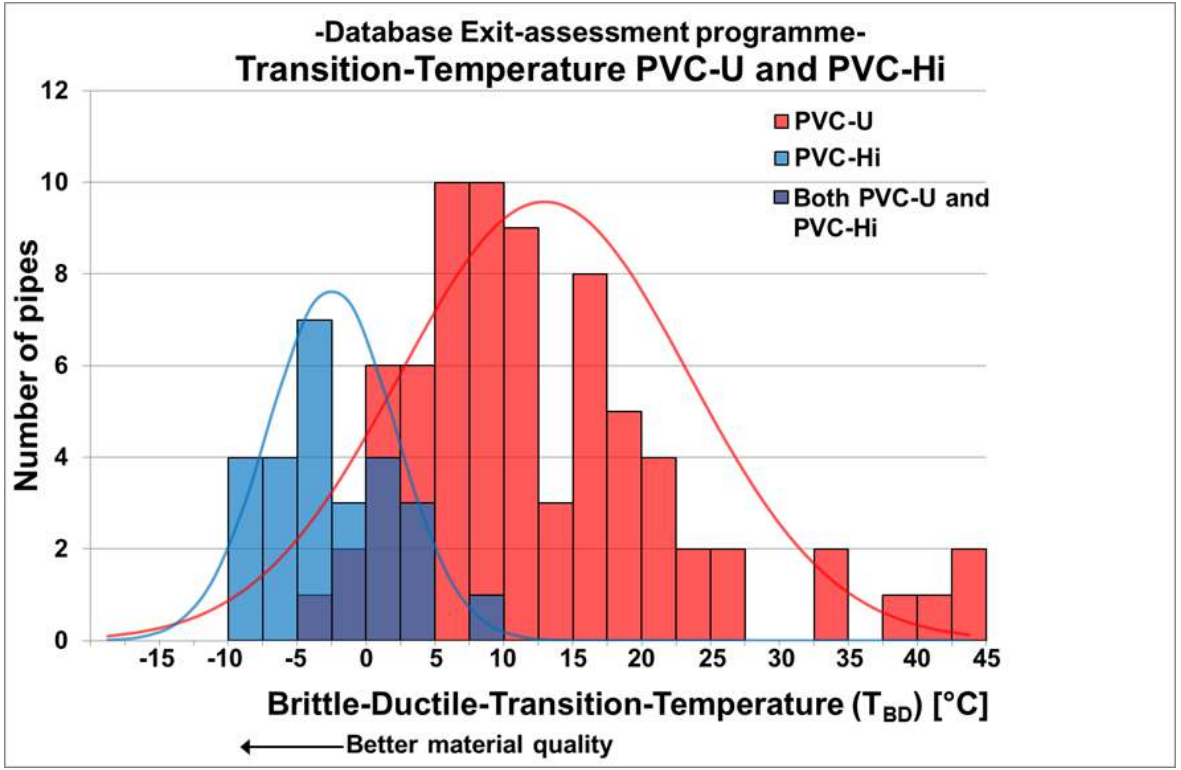
Results Exit assessment programme

- Annually 15 samples of both PVC-U and PVC-Hi
- Additional information from distribution system operator on:
  - Installation date
  - Dept of installation
  - Type of installation
  - Ground water level
  - Et.cetera

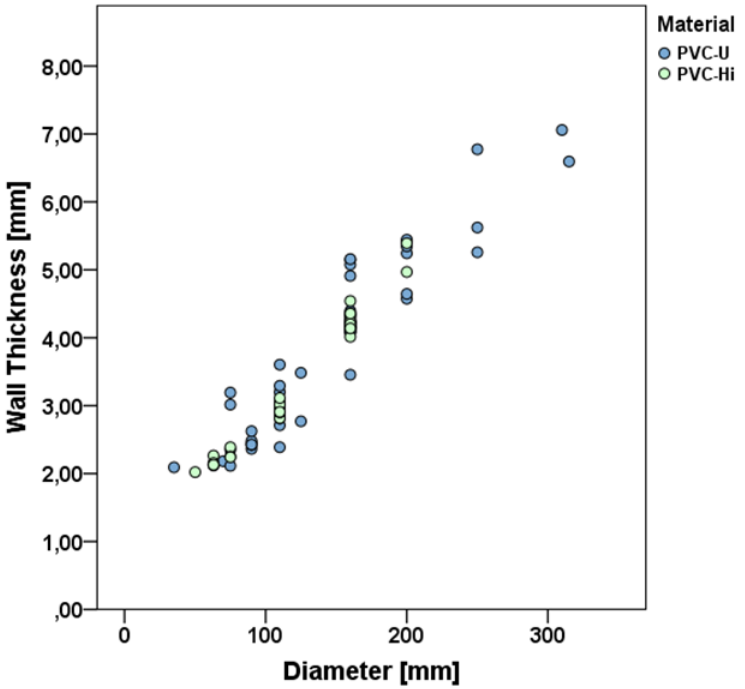
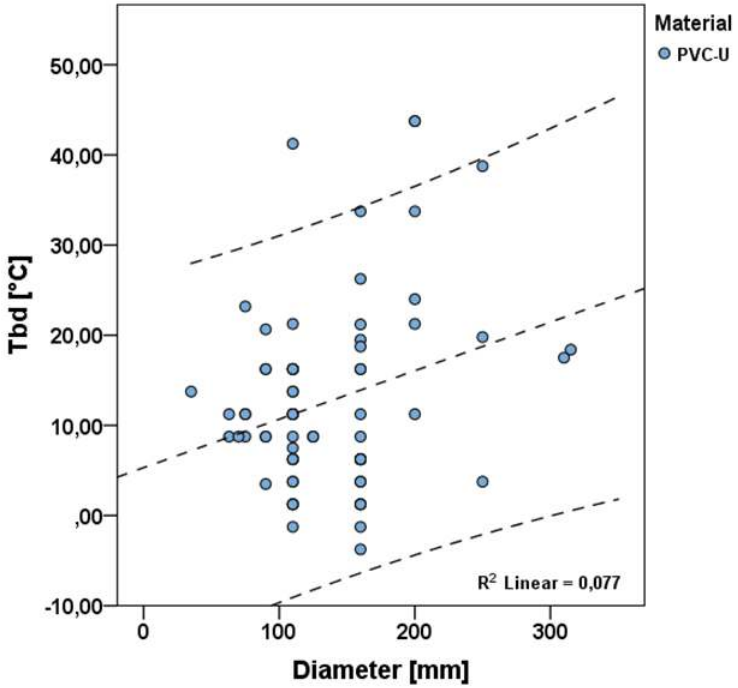
Trend between the brittle-ductile-transition-temperature (T_{BD}) and the diameter of old PVC-U pipes (right) and relation between wall thickness and diameter of the pipe (left).

- The improved impact test is able to distinguish sub populations of PVC pipes in the Dutch gas grid, based on material quality.
- The DSOs can use this information to optimize their replacement prioritization
- A larger diameter and therefore a thicker pipe wall seems to negatively influence the material quality of PVC-U by elevation the T_{BD}
- PVC pipes which are produced later in time have a better material quality
