Resistance of PVC pipes against Disinfectants

Joël Fumire – PVC4Pipes

Communication for PPXIV (September 2008)

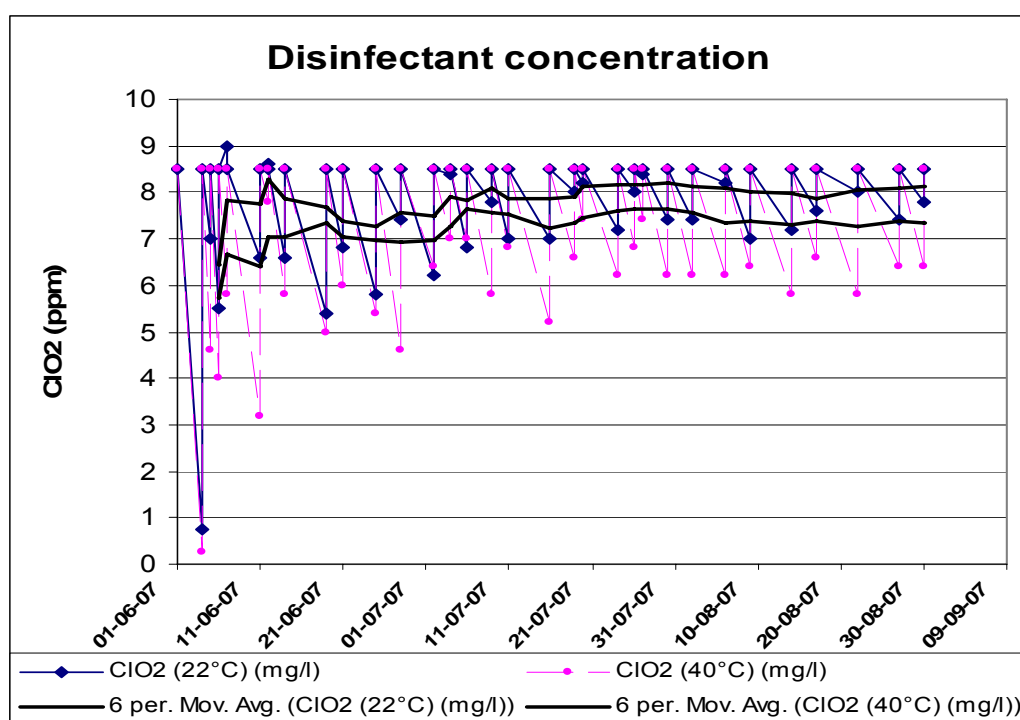
The concentration of ClO₂ in the exposition vessels is decreasing with time (decay of ClO₂) and was kept approximately constant by regular analysis and addition of the missing amount of ClO₂ (see fig. 1 for the high concentration case).

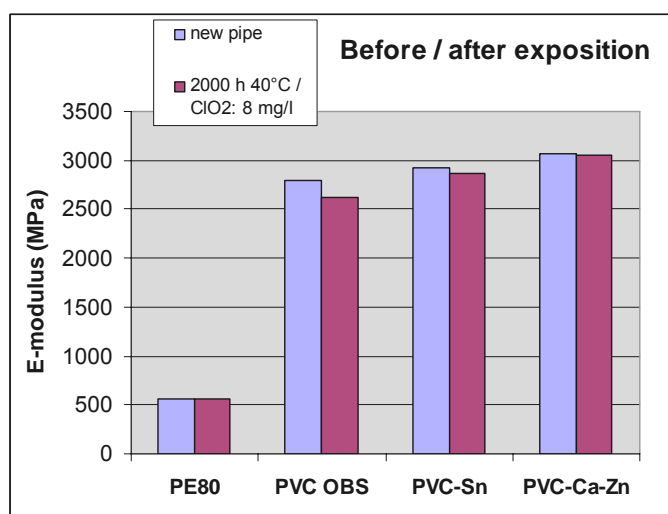
The E-modulus was measured before and after exposition (fig. 2).

No significant changes were registered for any type of pipe and all residual values of E-modulus are > 83 % of initial value (= satisfactory according to the requirements of ISO 4433).

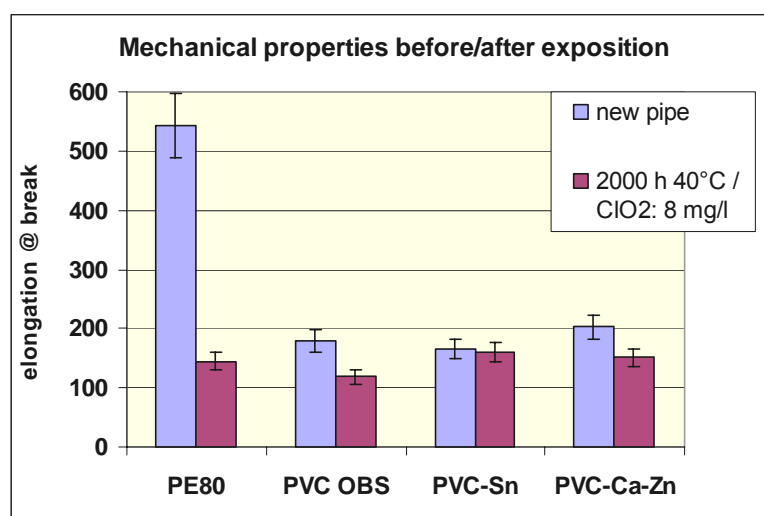
The Elongation at break was also measured for these conditions (fig. 3).

With these very hard conditions, the elongation at break shows that PE becomes brittle (Residual elongation at break : $Q_B < 30\%$ of the initial value) but the PVC does not undergo significant modification ($Q_B \gg 50\%$ = inside the limit-levels of ISO 4433).

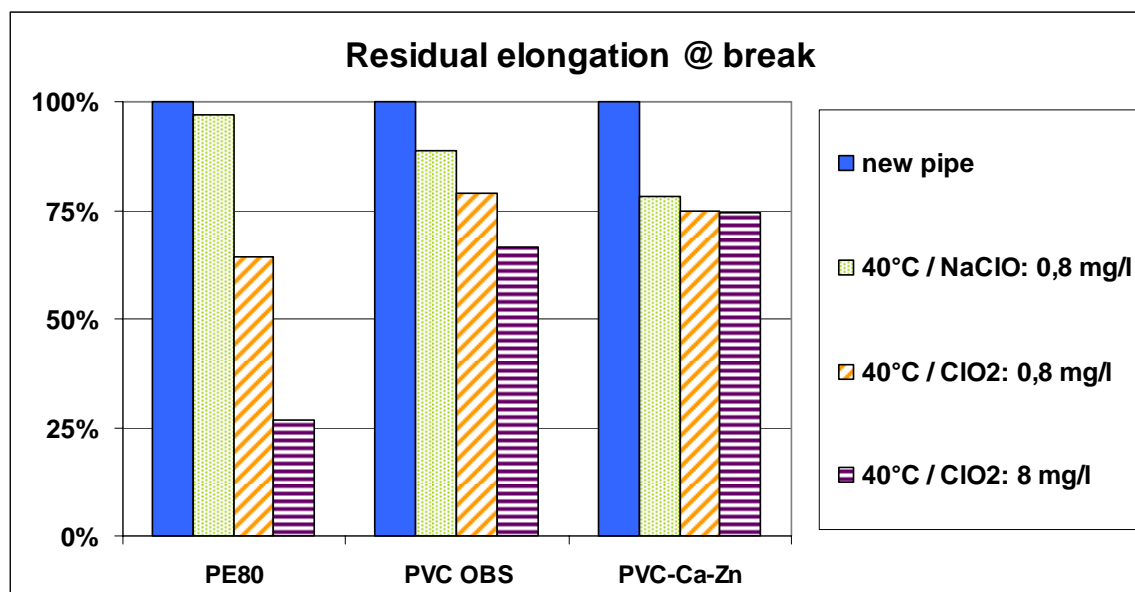
The ratios of remaining elongation at break (Q_B) after different types of expositions were established, they are given in fig. 4 :

The PE pipe exposed to the high concentration of disinfectant (8 ppm) show an important reduction compared to the initial elongation at break. For the PVC pipes the elongation at break is not strongly reduced (always > 60% of initial value) and is still considered as suitable according to ISO 4433.

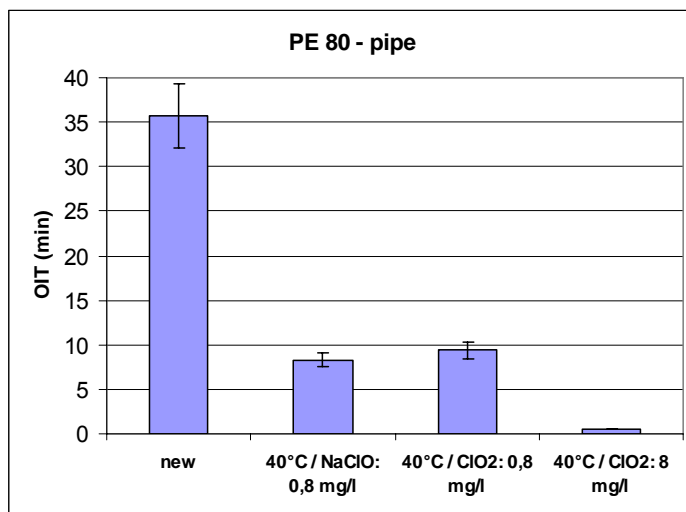
- For PE : we confirm that oxidation is the main cause of the loss of properties since the OIT (Oxygen Induction Time) is strongly reduced for expositions to high concentrations of ClO₂ (fig. 5)
- For PVC : The overall thermal stability by DHC is related to the stabiliser system but the exposition to disinfectant does not lead to any loss in stability (fig. 6).

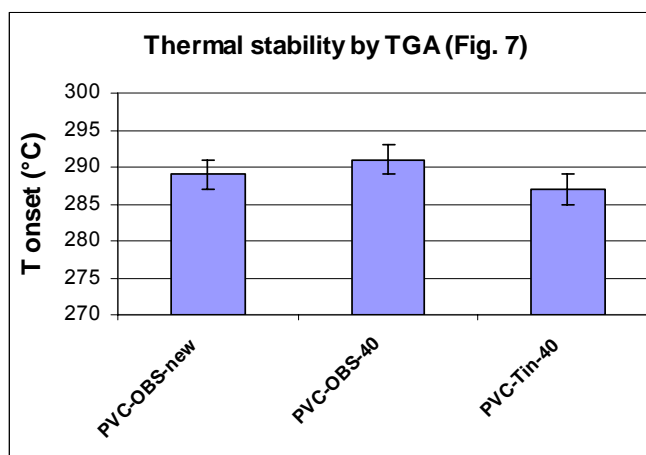
- The thermal stability by TGA (Thermo Gravimetric Analysis Fig. 7) as alternative method confirms that there is no significant difference in degradation temperature or oxidation ability for the exposed or unexposed samples (expositions at 40°C and concentr. 8 ppm ClO₂).

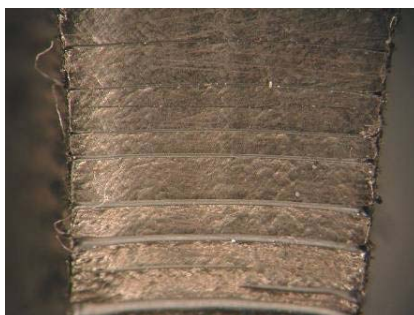
PE80 exposed (fig. 9)

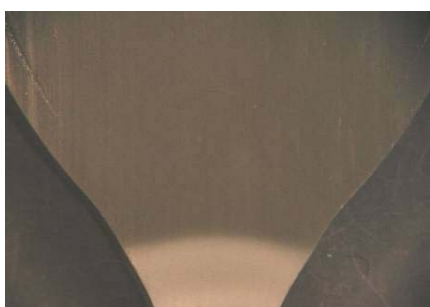
PVC (OBS) new (fig. 10)

The optical microscopy does not show any degradation of the PVC surface after exposition to the hardest conditions.

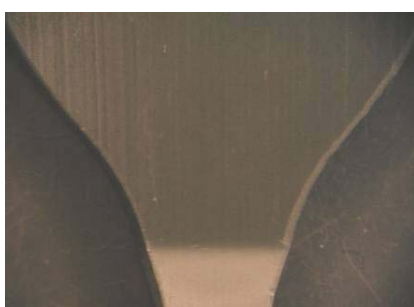
PVC (OBS) exposed (fig. 11)

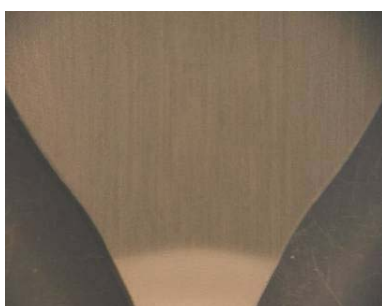
PVC (Ca-Zn) exposed (fig. 13)
